## Definition of “relevant” cases for further evaluation in the JNS “Consequences of unintended brake applications with LL blocks”

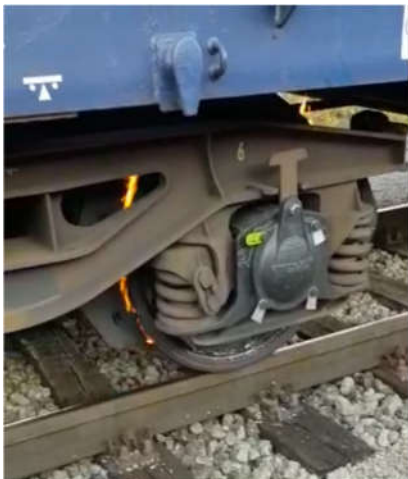
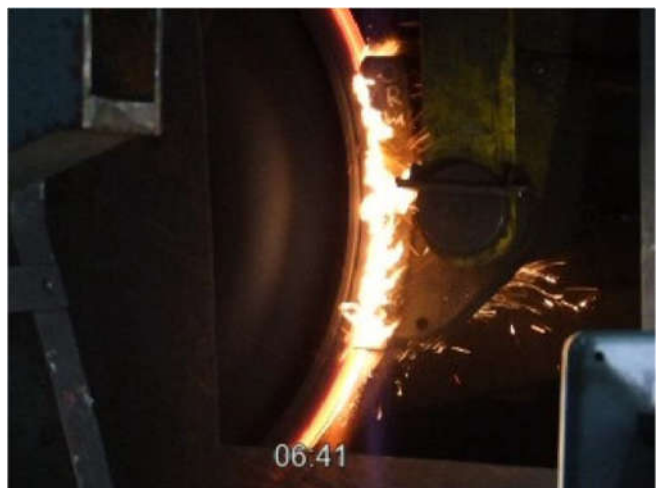
- Open flames on the brake blocks
- Signs of fire beside the track
- Any Signs of fire reported on the wagon

Examples for open flames:

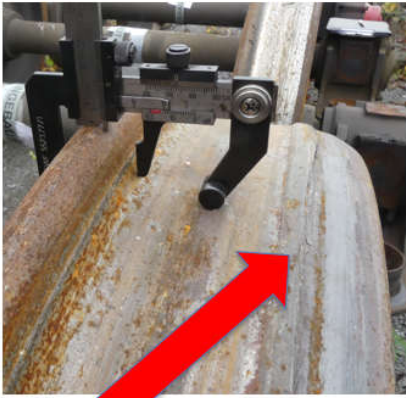
Extraordinary wheel tread deformation on the outer side of the tread

The measurement tool is not part of the assessment

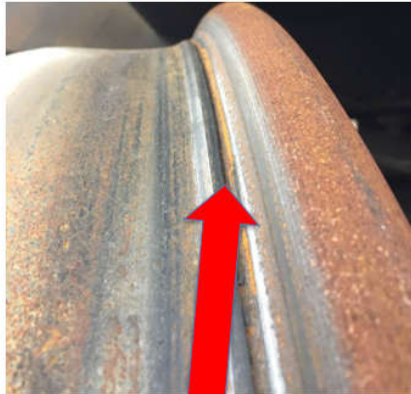
Extraordinary wheel tread deformation near the flange

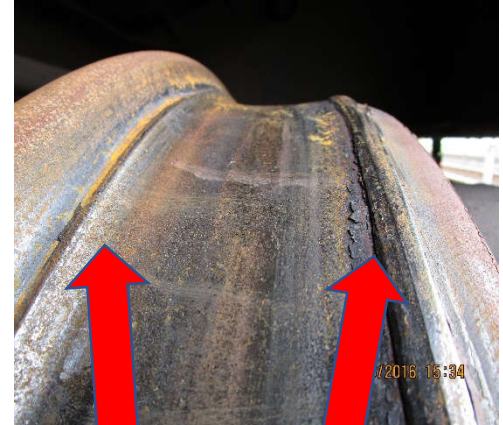
Extraordinary wheel tread deformation on the outer side of the tread and near the flange

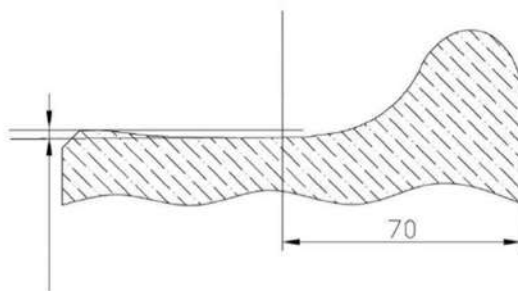
Figure C.19 — Definition of false flange

- Hollow wear / false flange like defined in EN 15313 **is not** a relevant case for the collection of the data related to the content of this JNS and should be treated in compliance with GCU and the maintenance rules.
