Oggetto: Safety Alert. Problemi rilevati alla piastra di usura del perno centrale dei carrelli serie Y e simili.

URGENT SAFETY ADVICE

1. INCIDENT DESCRIPTION			
LEAD / INSPECTOR	Graham Clark	CONTACT TEL. NO.	01332 253312
INCIDENT REPORT NO	0776	DATE OF INCIDENT	23 March 2015
INCIDENT NAME	Derailment at Washwood Heath West		
TYPE OF INCIDENT	Freight train derailment		
INCIDENT DESCRIPTION	<p>At 08:03 hrs on 23 March 2015, the failure of signalling equipment in the vicinity of Washwood Heath West Junction, Birmingham, following the passage of train 4O14, alerted the Network Rail signaller to a possible problem with that train. It was subsequently discovered that the train had derailed and then re-railed when crossing from the Up Derby Slow line to the Down Derby Fast line. The train was brought to a stand at Landor Street Junction at 08:10 hrs and the driver was asked to examine the train. He found evidence that the 10th wagon on the train had run derailed.</p> <p>Train 4O14 was the 05:58 hrs Basford Hall (Crewe) to Southampton container service. It consisted of a Class 66 locomotive pulling a mix of 24 container wagons and had been travelling at 15 mph while negotiating a series o

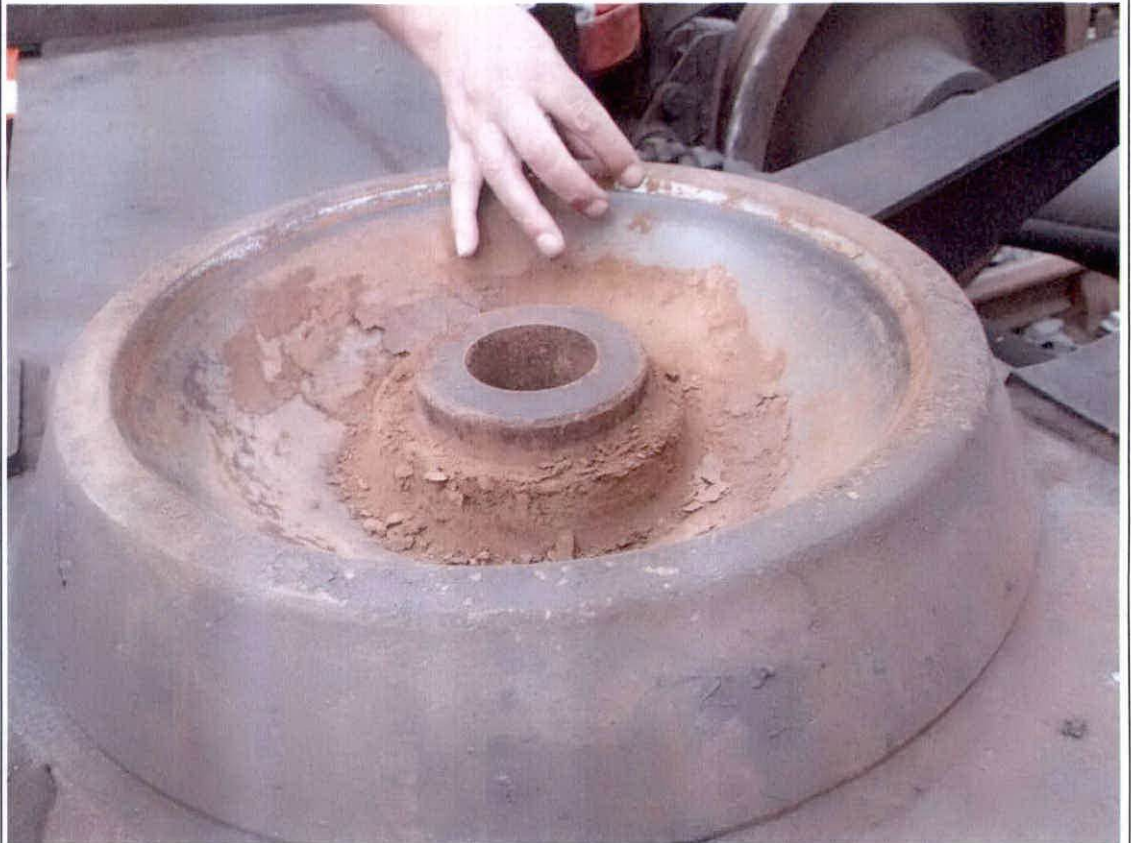
Figure 2: Centre pivot liner worn below level of steel rim, leading to contact between steel surfaces

CONSEQUENCES	Risk of wagons derailing on track which is curved or which contains a twist with a magnitude that does not require immediate closure of the line.
SAFETY ADVICE:	<p>The life of centre pivot liners will be dependent on the material that they are made from. Where the maintenance plan for a vehicle has been devised on the basis of using a particular type of centre pivot liner with a known rate of wear, Entities in Charge of Maintenance (ECMs) should ensure that the specified liner, or one with the same (or better) rate of wear, is always fitted (regardless of whether the maintenance is done by their own staff or by contractors).</p> <p>The liner should not be substituted for one with different wear characteristics unless the ECM has previously revised the maintenance plan to take account of the new liner. Where the wear characteristics of a new liner are unknown, steps should be taken to understand them before installation.</p> <p>When it is decided to install a new liner with characteristics different to those specified, the adequacy of the existing maintenance regime should be assessed. In particular, the intervals between liner inspection and replacement should be set such that the regular maintenance activities ensure that the liner is replaced before it has worn to such an extent that it adversely affects the ability of the bogie to rotate or reduces the sidebearer clearance beyond its limit.</p>

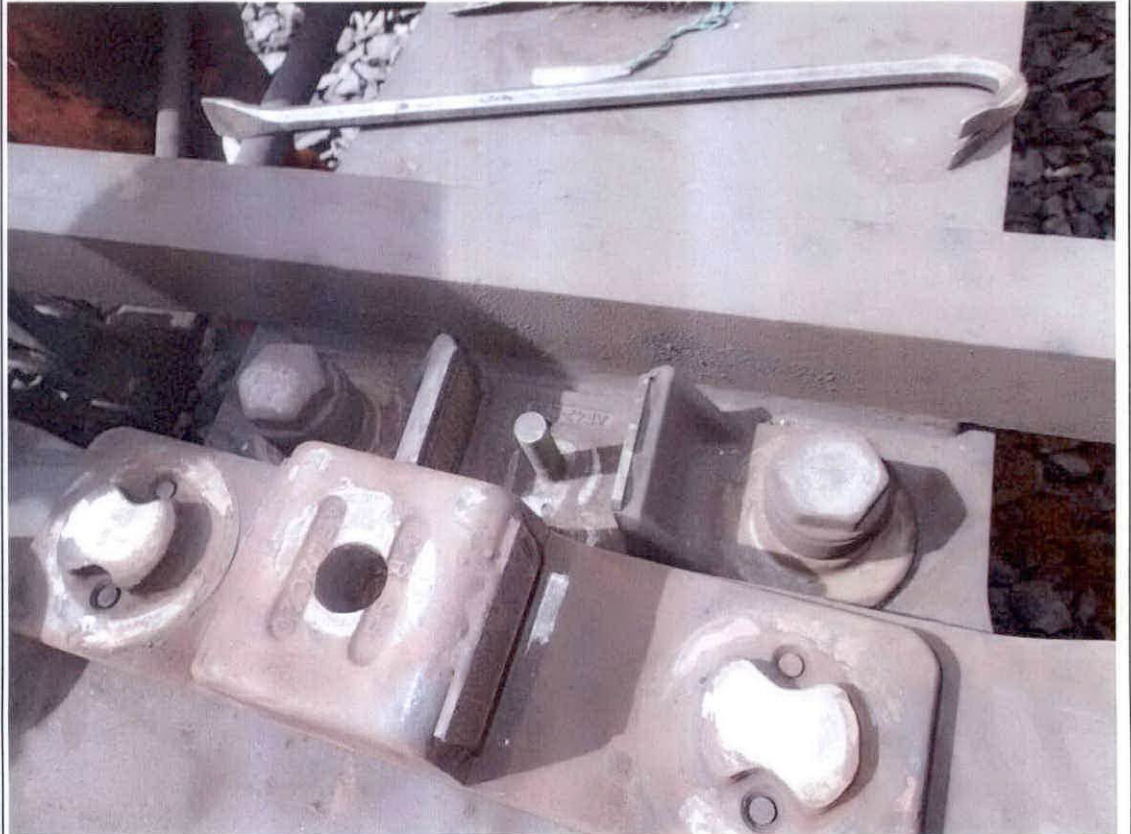
Figure 3: Sidebearer showing signs of frequent contact with end stops
