Oggetto: Safety Alert riguardante il rischio che container vuoti si distaccino, a causa del forte vento, da veicoli dotati di caviglie non conformi alla fiche UIC 571-4.

URGENT SAFETY ADVICE

2. URGENT SAFETY ADVICE	
USA DATE:	25 March 2015
TITLE:	The control of risks associated with spigots that are non-compliant with UIC standard 571-4, particularly inward hinging designs.
SYSTEM / EQUIPMENT:	Container carrying wagons fitted with UIC spigots

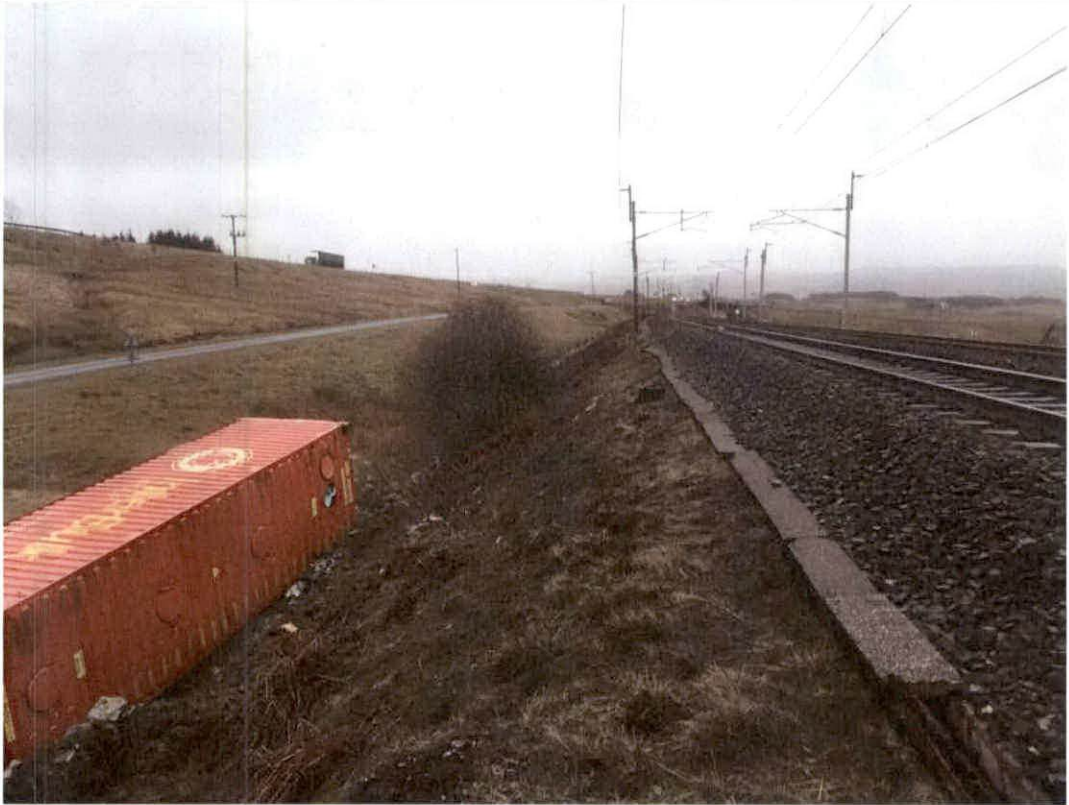
1. INCIDENT DESCRIPTION			
LEAD / INSPECTOR	Andy Hall	CONTACT TEL. No.	01332 253306
INCIDENT REPORT NO	0744	DATE OF INCIDENT	7 March 2015
INCIDENT NAME	Scout Green		
TYPE OF INCIDENT	Container blown off freight train		
INCIDENT DESCRIPTION	<p>At around 02:20 hrs on 7 March 2015, an empty 30 ft container was blown off an FEA(B) wagon, that formed part of train 4S83 operated by Freightliner. The train was travelling at around 75 mph (120 km/h) on the Down Main line in the vicinity of Scout Green, Cumbria, around 2.5 miles south of Shap Summit. The container passed over the adjacent Up Main line and came to rest at the bottom of the Up side embankment. There was no damage to train 4S83, any other train, the overhead line equipment or the track. Trees on the embankment and a boundary wall at its foot were knocked over.</p> <p>The incident took place at a time of high cross-winds. Although it did not result in injuries, the potential for more serious consequences is evident.</p>

<p>[Image courtesy of Network Rail (looking south)]</p>
