Oggetto: Inconveniente carro nei Paesi Bassi – Perdita in linea del piatto e della custodia di un respingente.

Safety Warning

Wear of locking ring for cover of buffers.

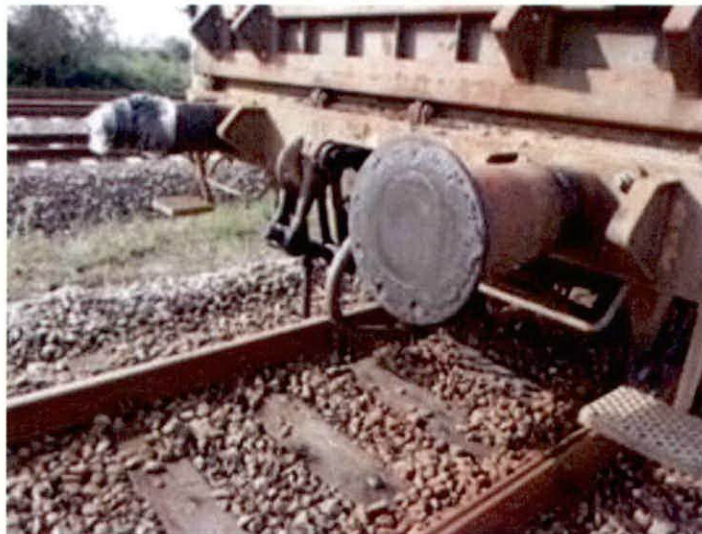
Due to wear of the locking rings in the cover of a buffer the bufferplate with the cover felt into the tracks. A following train hit the bufferplate with the cover and damaged the transponders for the signaling systems of the locomotive.

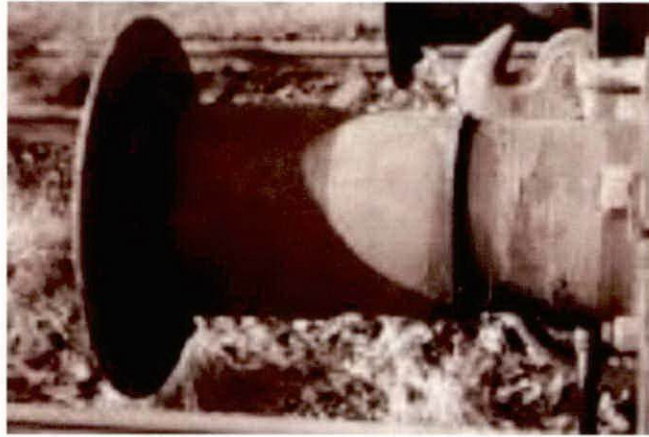
An inspection of the components of the buffer involved learned that the locking rings showed wear. The thickness at the corners of the (half) rings showed wear. Due to the wear the rings are pulled out of the grooves for the rings. The difference of the diameter of the cover for the buffer plate and the cover for the buffer feet was big enough to let the locking rings pass by.

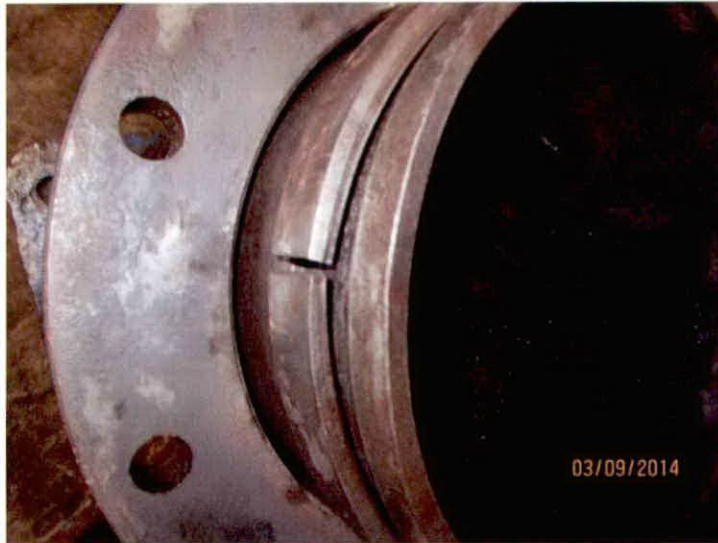
Saving of locking rings in buffer feet

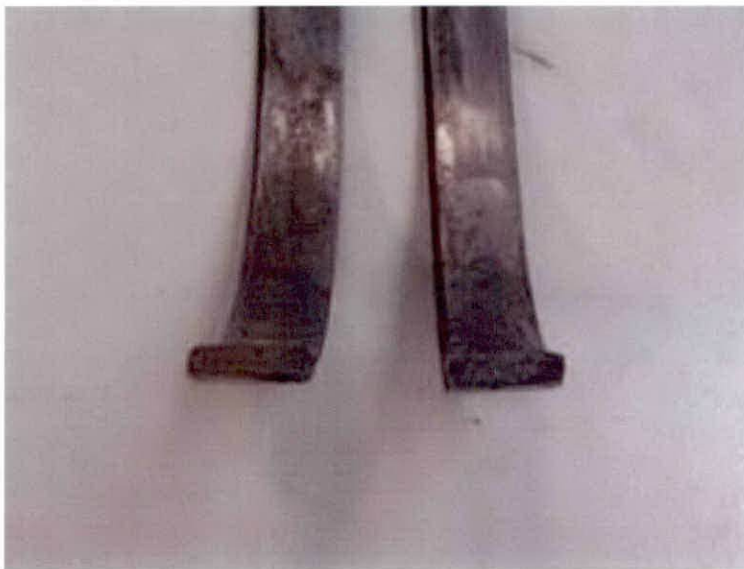
Diameter difference of locking rings and saving for locking ring
