**Oggetto: Safety Alert relativo a carri container della serie Laagrss.**

## SAFETY ALERT

## SAFETY ISSUES REGARDING WAGONS

Laagrss

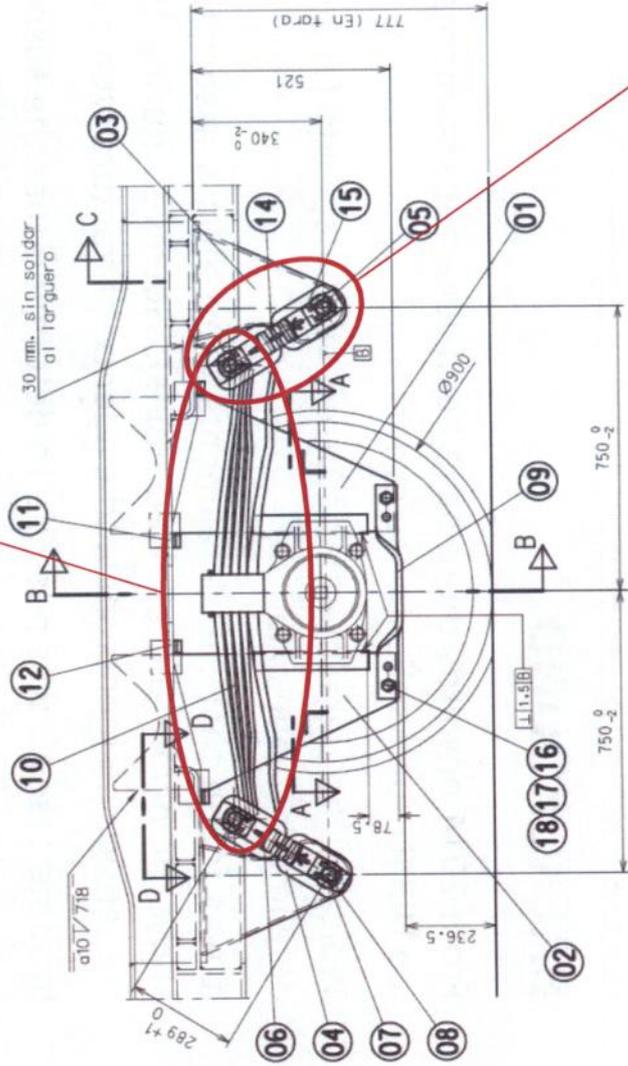
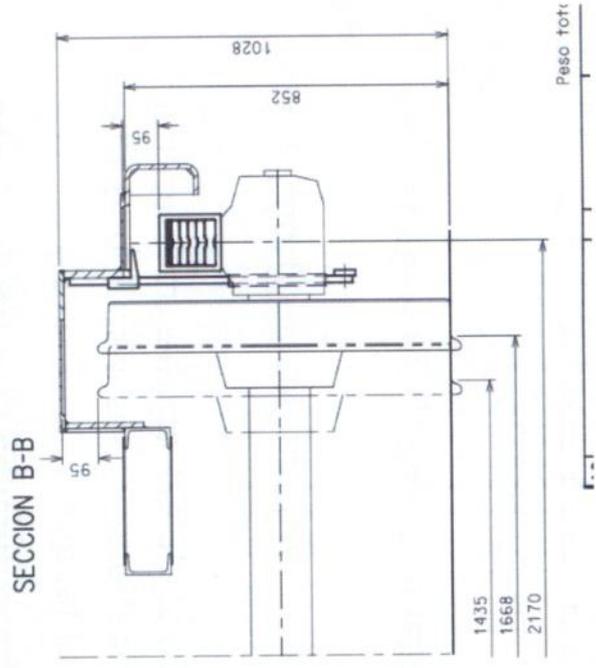
UIC parabolic spring for bogies

UIC double link suspension

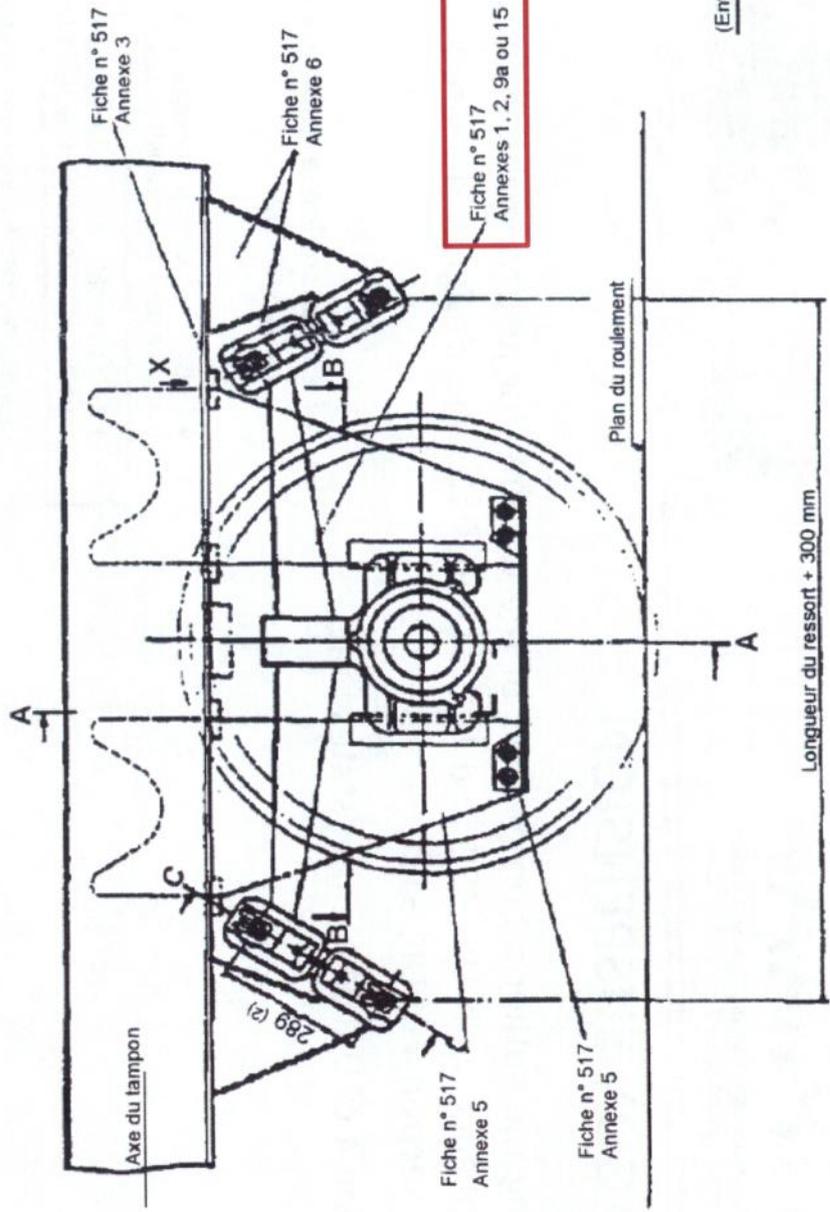
### Organes de roulement et de suspension des wagons à 2 essieux

- Running gear suspension **does not comply** with UIC 517 standard for 2 axle wagons;
- Parabolic spring for bogies could be used only if subjected to tests prescribed in UIC 517 Annex 15 (annex M in present version of leaflet);
- Wagon **could not be exempted** from dynamic tests for compliance with UIC 432 and UIC 518 leaflets

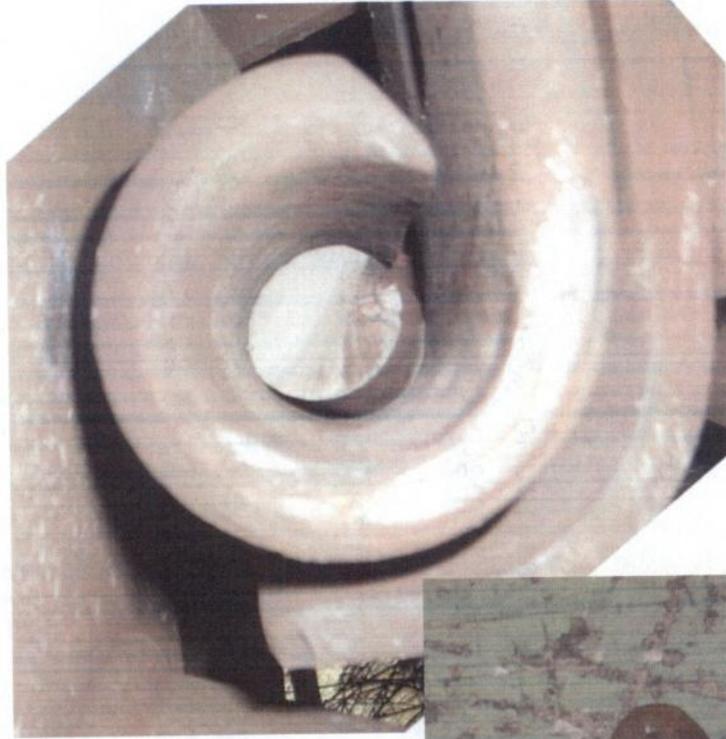
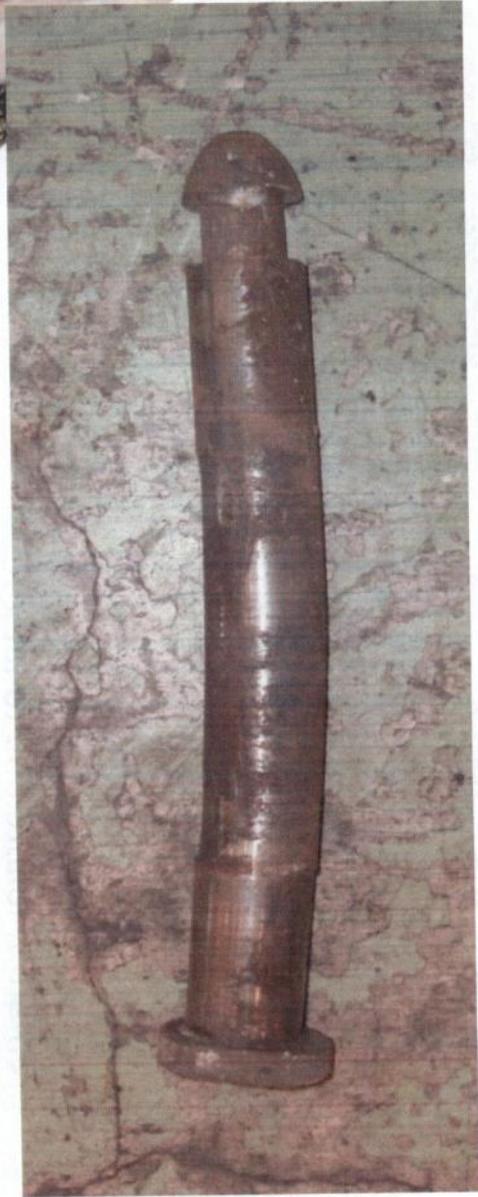
- From the evidence gathered during the investigation, it was found that the suspension elements are heavily stressed, reaching levels near the limit strength and resulting in their premature failure due to fatigue.
- The dynamic behaviour of the wagon, under certain operating conditions, exceeds the limits allowed by the applicable standards and regulations.
- The relevance of these facts depend on the magnitude and type of forces exerting in the wheelsets' suspension, being critical factors for its importance the track geometrical defects and the associated running speed, as well as the loading of the wagon.

High stresses and fatigue in suspension components

- The suspension and the safety of the wagon against derailment should be rechecked accordingly to the original requirements in the applicable standards, as the original statement of compliance with section 4 of UIC 517 has proven inaccurate;

- According to the results of the tests above and taking into consideration the return of experience from the years of use of these wagons, measures relating to operation conditions, changes in the design and/or the maintenance plans, should be put in place to minimize the risks of derailments due to premature suspension failure and/or dynamic behaviour of the wagons;

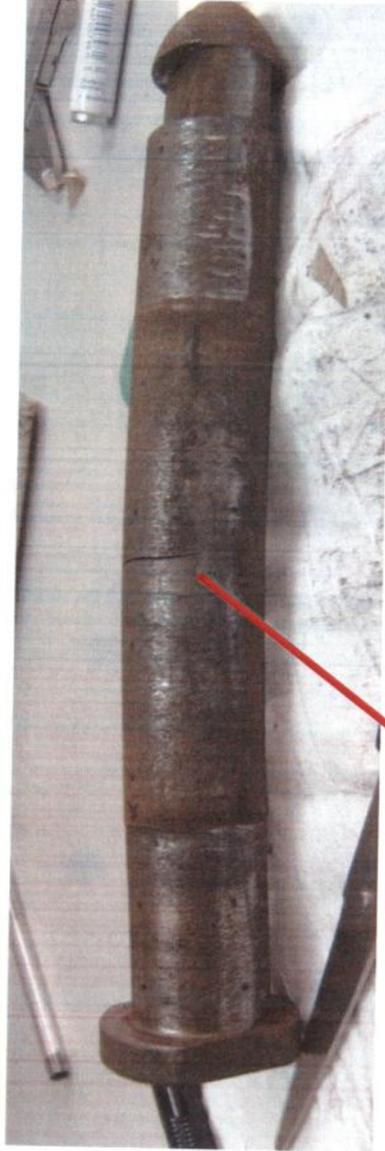
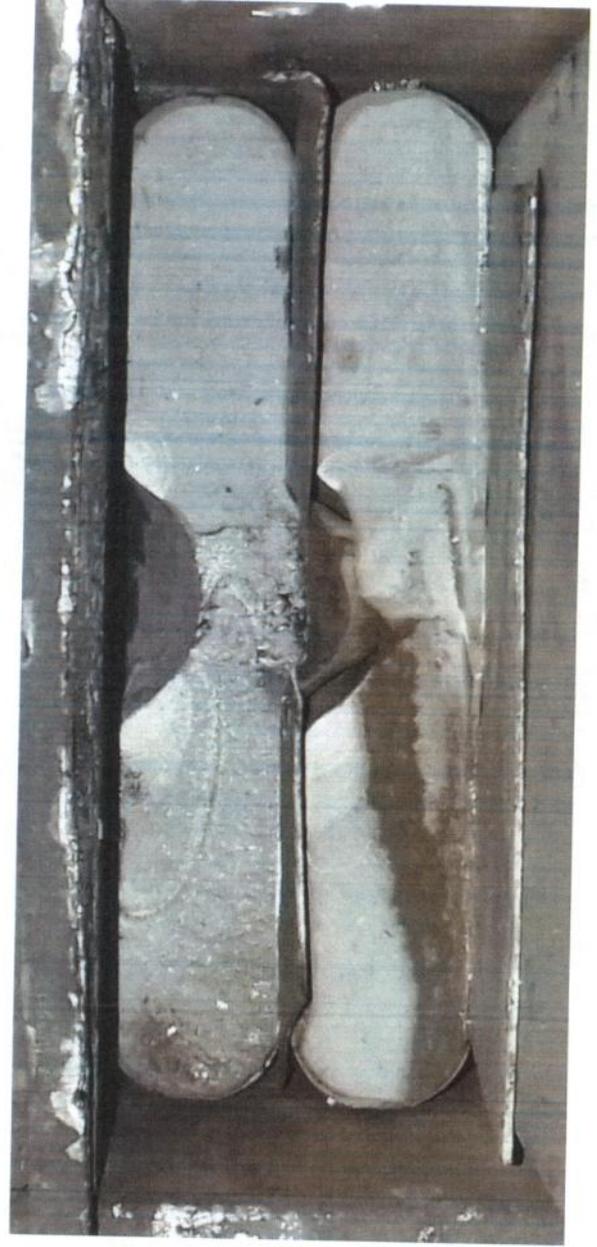
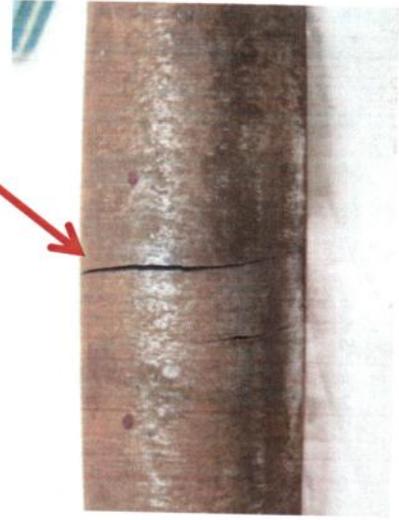
High stresses and fatigue in suspension components

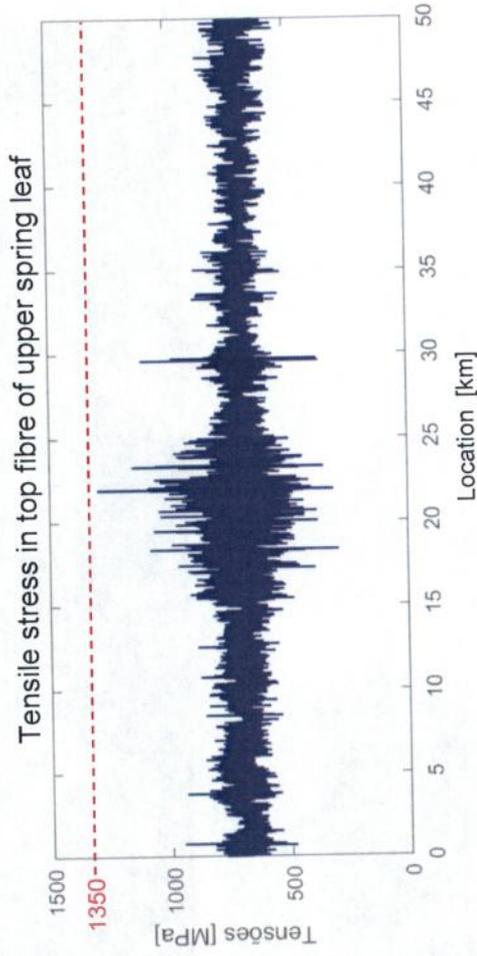
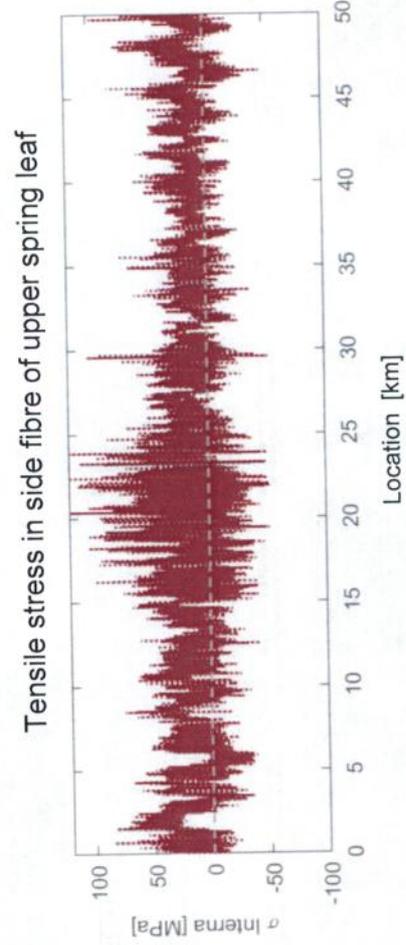
### High stresses and fatigue in suspension components

Evidence indicates that the suspension elements are subjected to heavy stresses and that the fatigue limit is reached much sooner than expected.

The spring develops high tensile stresses both in the normal flexing plane and in the transversal plane of the leaves.

On a normal run with an instrumented wagon, NIB PT observed that the maximum permitted stress of 1350 MPa on the top fibre of the upper spring leaf was nearly reached, indicating that in some fibres of the metal this value is frequently exceeded when combined with the bending stress in the lateral plane.

NOTE: The dynamic test data was taken on a commercial run with a wagon loaded at 20,6 t/axle, so it is not representative of all operating conditions of this type of wagon.

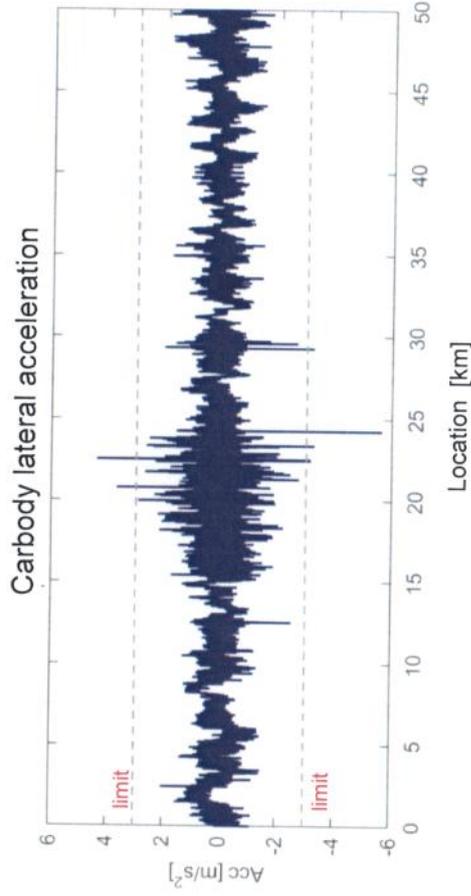
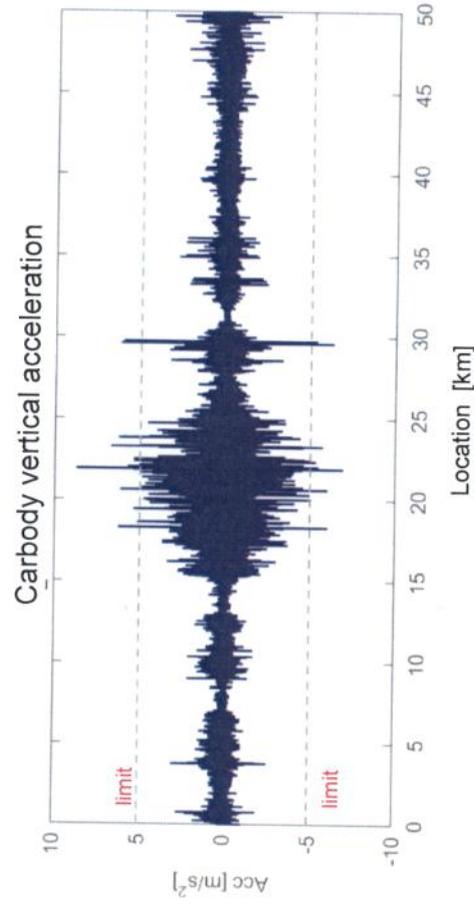
### Dynamic behaviour

Measurements performed during the investigation, indicate that the dynamic behaviour of the wagon **exceeds the normative limits for lateral and vertical accelerations**, at least when running on track close to immediate action limits.

On a normal run with an instrumented wagon loaded at 20,6 t/axle, NIB PT observed that the vertical accelerations attained maximums of +0,9g and -0,7g, meaning that there are wheel loads applied to the track well above the dynamic coefficient expected, as well as reductions in the vertical wheel load that can favour a derailment by the corresponding increase in the Y/Q ratio.
