**Oggetto: Safety Alert relativo a problemi connessi all'utilizzo di soles del freno, realizzate in  
materiale composito, a bassissime temperature.**

## SAFETY ALERT

| <b>SYSTEM/ EQUIPMENT</b> | Composite brake blocks in winter conditions | |

# Winter conditions and composite brake blocks Annex

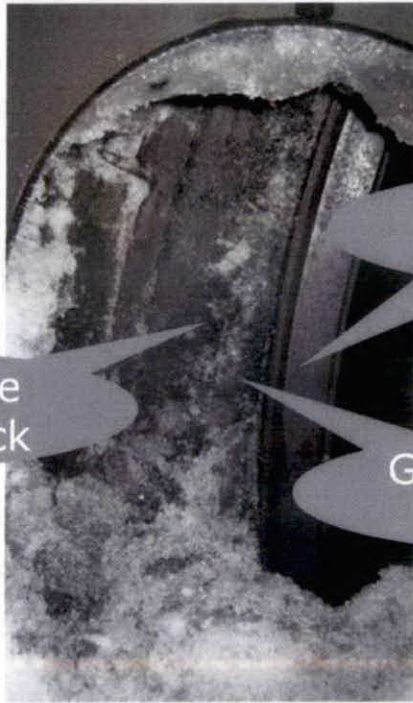
Wheel

Composite  
brake block

Gathered ice  
and snow

- Composite brake blocks cause safety problems in Northern Europe
- Multiple near-miss situations and feedback from train drivers of braking problems after raw timber trains, consisting only of composite brake block equipped wagons, began operating.
- Incidents caused by prolonged braking distances due to accumulation of ice and snow

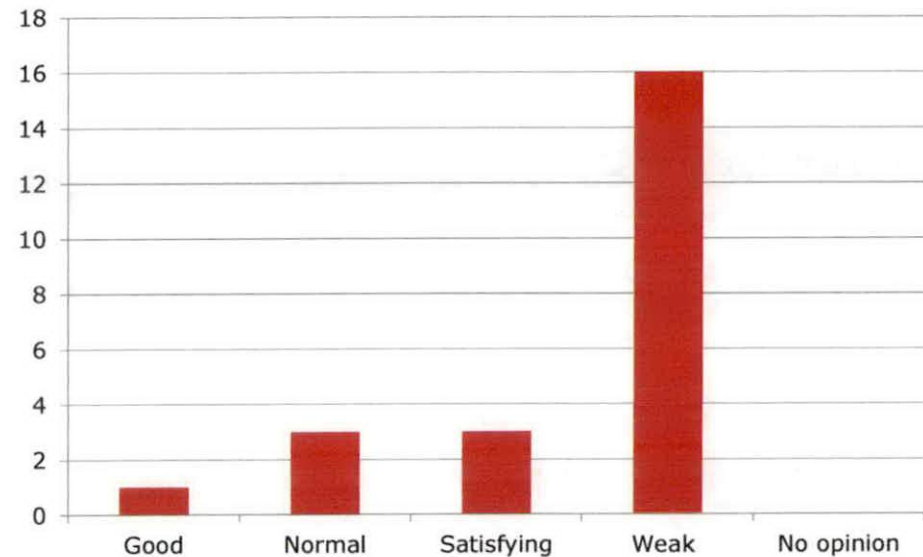
## Assesment of braking performance

Majority of the train drivers considered the braking performance of composite brake blocks weak.

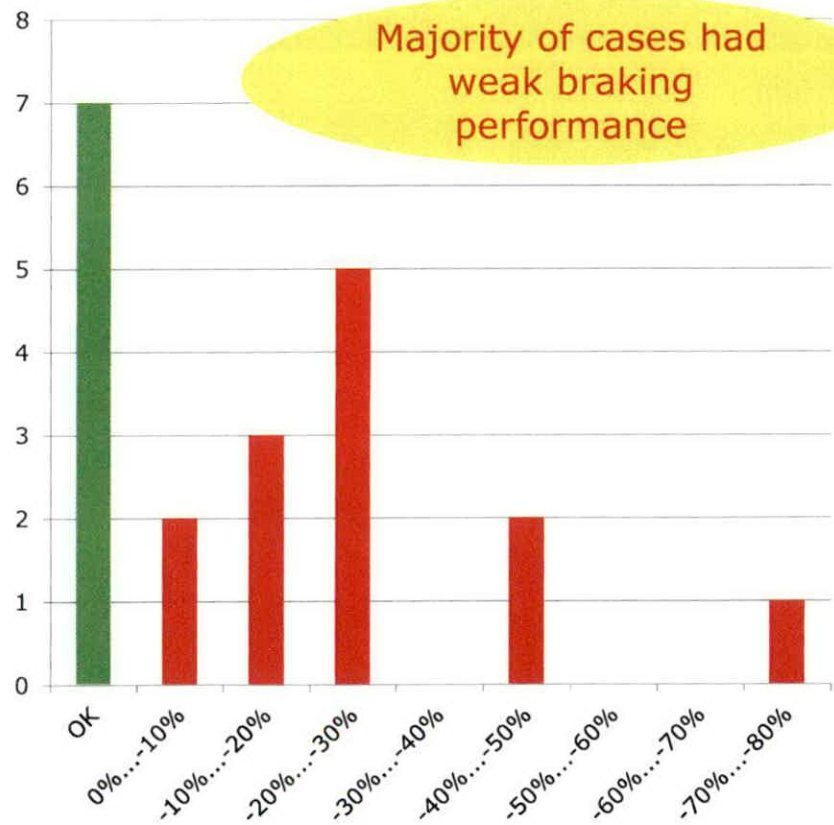
Actual deceleration in comparison to nominal minimum value

- Less than nominal decelerations are shown in the red piles, which indicate prolonged braking distances. Less than -40% would indicate a very low braking capability.

- 13 out of 20 cases in the sample material had prolonged braking distances, which means in these cases the braking performance is less than allowed
- 7 out of 20 cases in the sample material had normal braking distances. This variety in the results also indicates that the braking performance cannot be anticipated by the driver and the risk of sudden loss of brakes emerges.

- These measures have unfortunately been ineffective and have not provided a solution the problem.
- The technical solution to provide better braking performance is to increase the number of vehicles with cast-iron blocks significantly or to replace the composite brake blocks completely with cast-iron blocks.
