ANSF Agenzia Nazionale per la Sicurezza delle Ferra DIST n° 009527/2017 04/09/2017

Rottura delle ruote dei veicoli merci. Misure mitigative a breve termine proposte dal JNS. Aggiornamento del Safety Alert relativo al rilevamento in esercizio della rottura di una ruota del veicolo NEV 336849544992.

Joint Network Secretariat Urgent Procedure Task Force Broken wheels

Agreement of the TF on short term mitigation measures

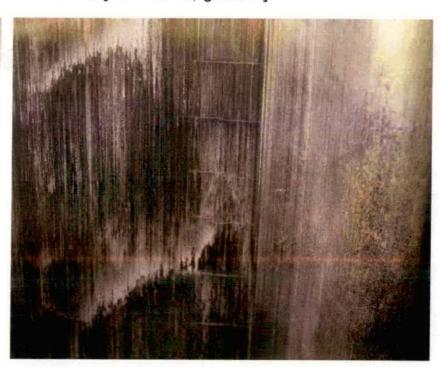
Description: The tread exhibits cracks at an angle of approximately 90° to the circumference of the wheel and have a typical length of 30mm or more. Transverse cracks generally develop at the surface in either straight or slightly crooked lines and can penetrate radially (usually of thermal origin in these cases) or branch out in a circumferential direction (usually of mechanical origin in this case). They occur individually and can be distributed at several points around the circumference. [EN 15313, §C.2.6.]

Example for single cracks on the wheel tread by visual inspection

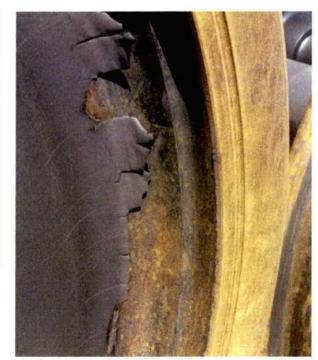
Description: This type of defect occurs only in tread-braked wheels. When suitable coatings are used, the paint becomes clearly burnt in the rib/web transition radius when the temperature exceeds approximately 300 °C. The paint in this area then becomes cracked and peeling. The brake blocks are often melted to some extent. Build-up of metal and characteristic colouring can be seen on the tread. The rim may also become a bluish colour.

Old and fresh burnt paint

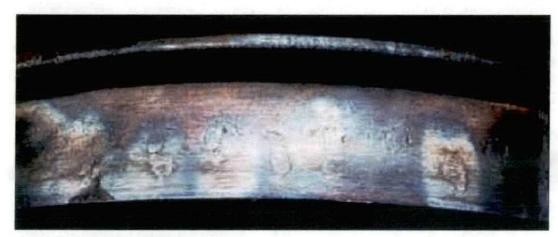
colouring on the tread

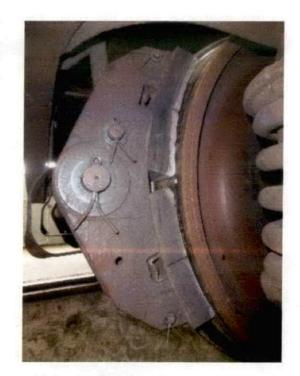
Melted brake block
