## Safety Infor... > Safety Alert > **Freight wagon type Laaiis- Wheelset type BA 390**

Safety Alert

Freight wagon type Laaiis- Wheelset type BA 390

## 1.1 Dinamica dell'evento

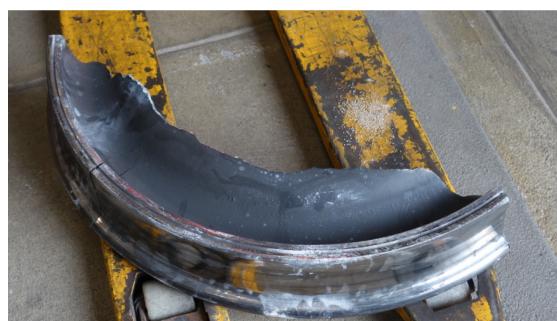
Circa 10 km dopo il portale sud (km ferroviario 47) è stato ritrovato un primo frammento di ruota accanto al binario (Figura 2).

**Figura 2:** Primo frammento staccatosi dalla ruota (foto scattata fuori dalla galleria).

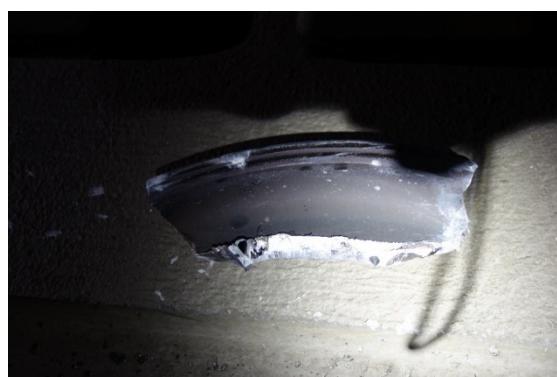
**Figura 3:** Altro frammento di ruota (foto: in galleria).

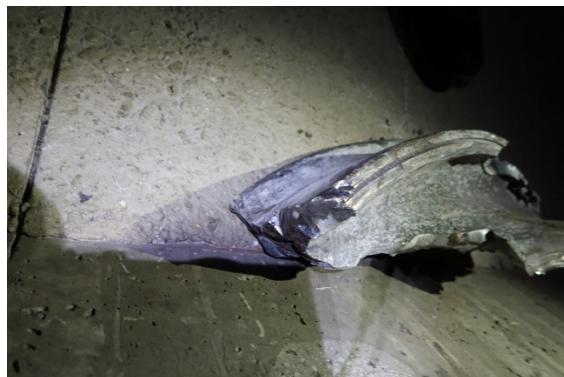
L'ultimo frammento è stato rinvenuto poco prima della stazione multifunzionale di Faido (all'incirca al km ferroviario 40.4) (Figura 4).

**Figura 4:** Ultimo frammento di ruota (foto: in galleria).

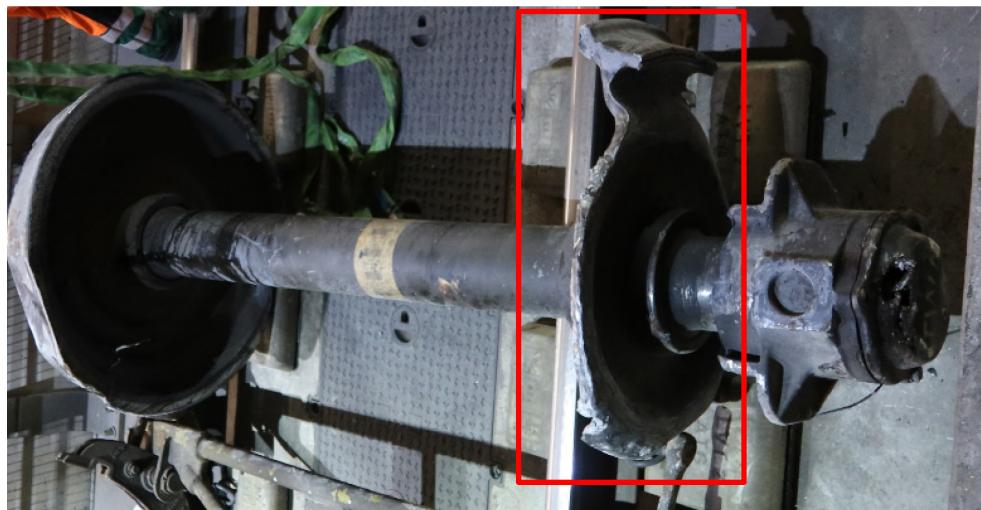
Dopo l'arresto del treno, il carro 11 si trovava all'altezza del km ferroviario 39.9. L'assile 1 (Figura 5) del suddetto carro era ancora sospeso in posizione obliqua sotto di esso.

**Figura 5:** Assile 1, carro 11: foto scattata dopo il recupero dell'assile. In rosso: frammenti mancanti sulla ruota destra.

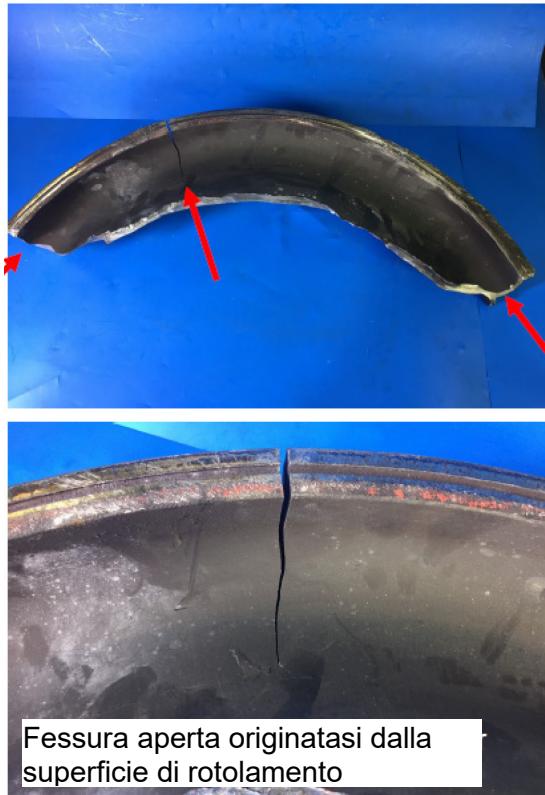
Il frammento grande (Figura 7) presenta su entrambi i lati cricche a fatica con diverse fessure aperte che partono dalla superficie di rotolamento (tensioni proprie).

Le cricche si sono propagate dalla superficie di rotolamento fino al disco.

Figura 7: Fessura aperta originata dalla superficie di rotolamento.

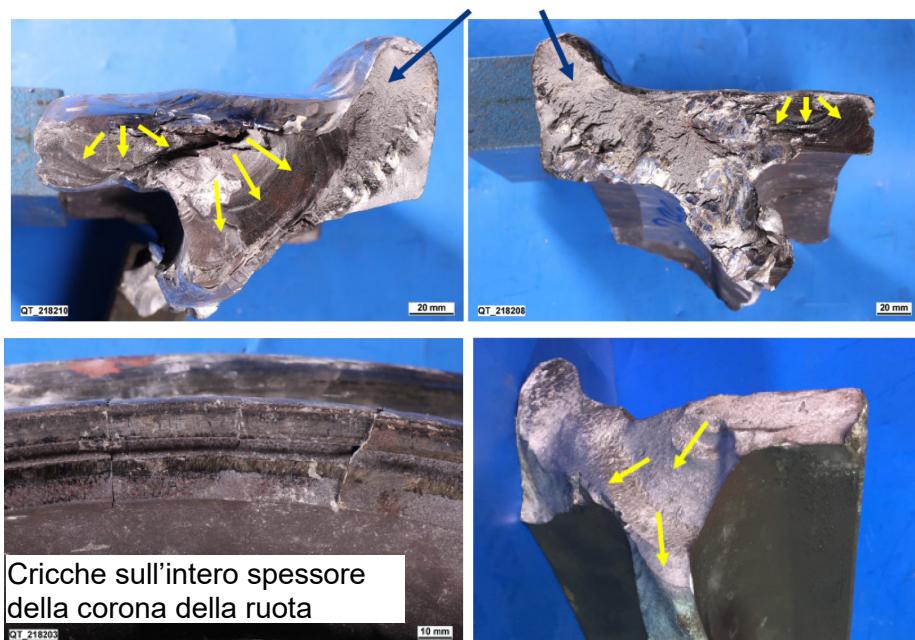
Tutte le superfici di frattura presentano cricche a fatica che partono dalla superficie di rotolamento.

Figura 8: Foto delle superfici di frattura. Frecce gialle: cricca propagatasi dalla superficie di rotolamento fino al disco.

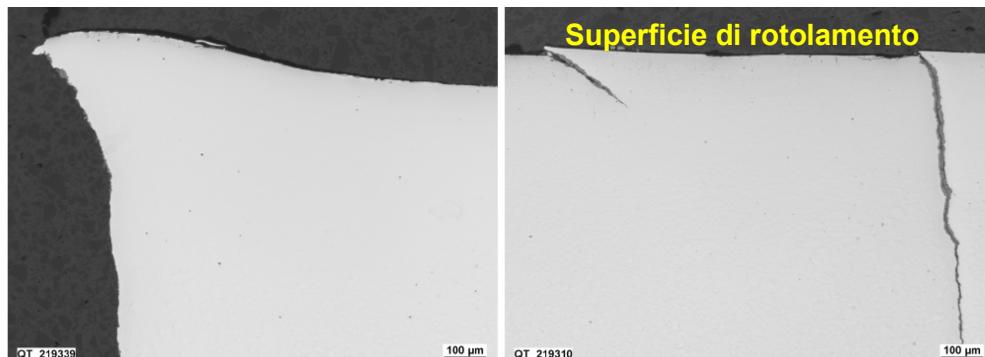
L'indagine al microscopio ottico evidenzia l'orientamento sia obliquo che verticale delle cricche rispetto alla superficie di rotolamento (Figura 9).

**Figura 9:** Cricche a sviluppo obliquo e verticale rispetto alla superficie di rotolamento.

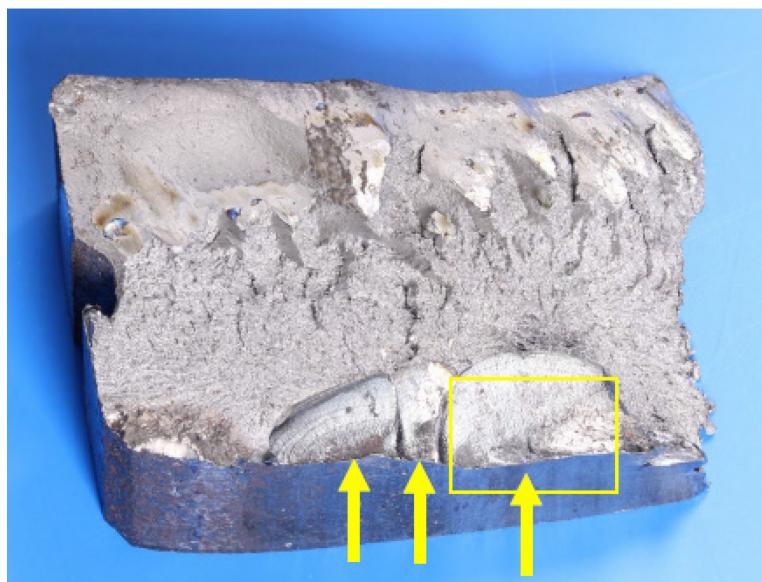
A livello microscopico si individuano vari punti di innesco della frattura sulla superficie di rotolamento (Figura 10).

**Figura 10:** Punti di innesco sulla superficie di rotolamento (frecce gialle).

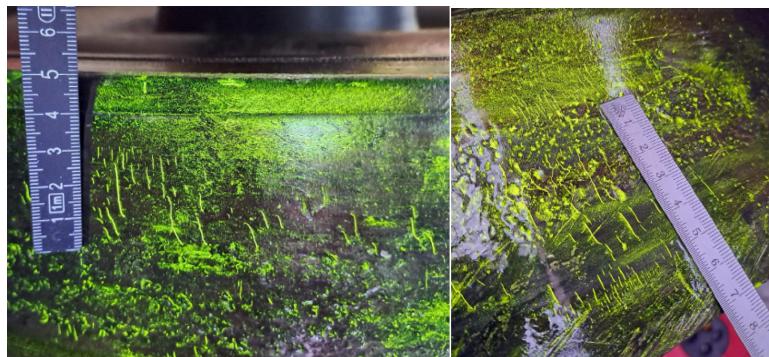
L'esame magnetoscopico ha prodotto, per le sale montate 2 e 3, riscontri di fessure lineari (circa 25–35 mm di lunghezza) in direzione assiale sulla superficie di rotolamento lungo l'intero perimetro.

Sulla sala montata 4 si sono registrati solo sporadici riscontri di fessure lineari (circa 15 mm di lunghezza) in direzione assiale sulla superficie di rotolamento.

**Figura 11:** Esami magnetoscopici alle sale montate 3 e 4.

Questi riscontri verranno successivamente sottoposti anche a esame metallografico e i relativi risultati documentati nel rapporto finale.

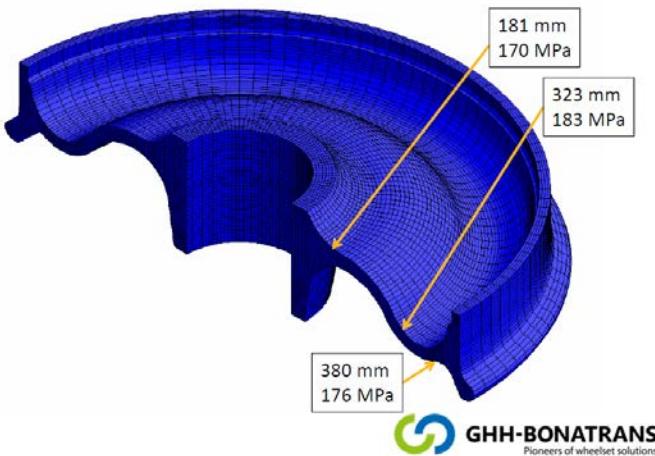
Wheel with slope - old design

- Position of critical point is in web on radius 323 mm on outer side.
- maximal stress amplitude in critical point of wheel web is 183 MPa.
- Stress amplitude in the area of crack (in inner side of web on radius 380 mm) is 176 MPa.

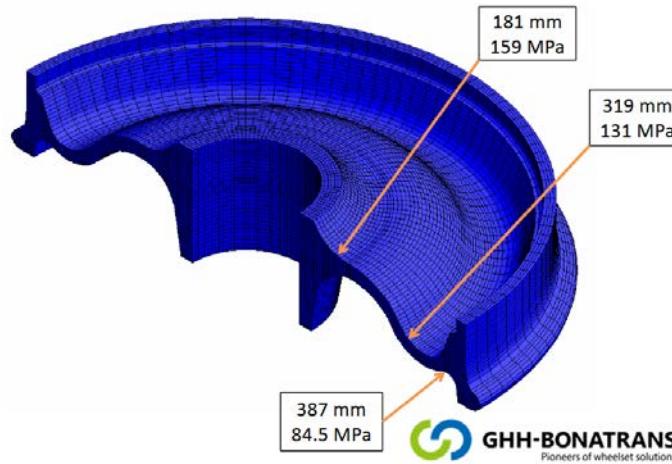
Wheel without slope – new design

- Position of critical point is in transition between hub-web on radius 181 mm.
- maximal stress amplitude in critical point of wheel web is 159 MPa.
- Stress amplitude in the area of crack (in inner side of web on radius 387 mm) is 84.5 MPa.

**Conclusion:** Change of design (without slope) reduces stresses in the web and in particular in the area of the crack initiation.

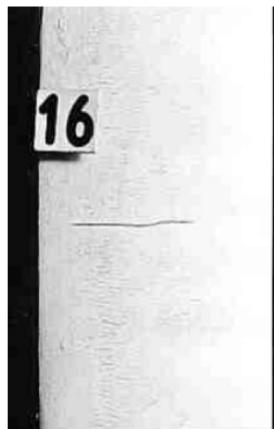
**Description:** The tread exhibits cracks at an angle of approximately 90° to the circumference of the wheel and have a typical length of 30mm or more. Transverse cracks generally develop at the surface in either straight or slightly crooked lines and can penetrate radially (usually of thermal origin in these cases) or branch out in a circumferential direction (usually of mechanical origin in this case). They occur individually and can be distributed at several points around the circumference. [EN 15313, §C.2.6 ]

Transverse crack revealed by magnetic particle testing [EN 15313, §C.2.6 ]

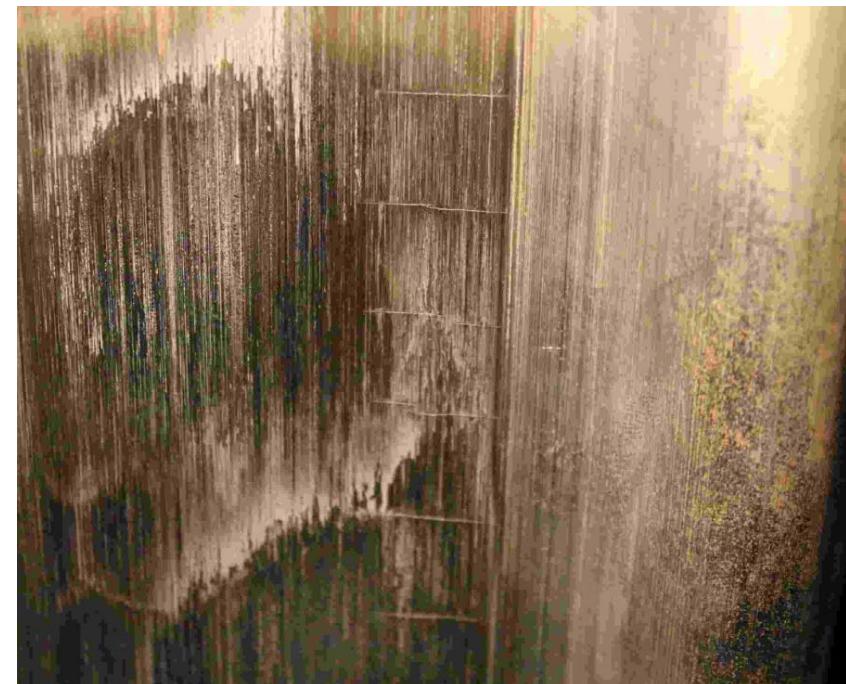
Example for single cracks on the wheel tread by visual inspection

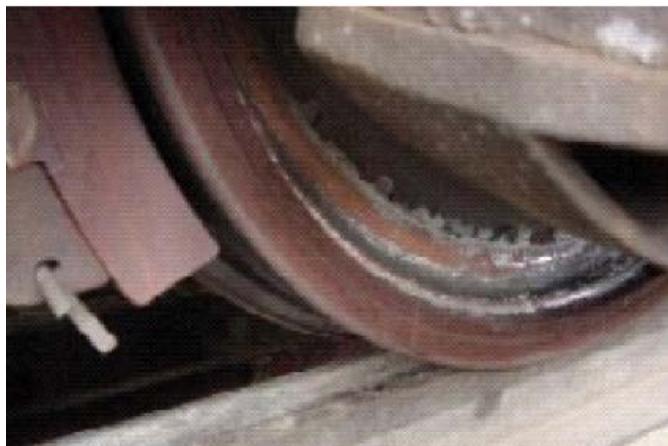
**Description:** This type of defect occurs only in tread-braked wheels. When suitable coatings are used, the paint becomes clearly burnt in the rib/web transition radius when the temperature exceeds approximately 300 °C. The paint in this area then becomes cracked and peeling. The brake blocks are often melted to some extent. Build-up of metal and characteristic colouring can be seen on the tread. The rim may also become a bluish colour.

If the problem is not detected immediately the rim/web transition can gradually assume a rusty appearance with shades between greyish-brown and brown covering the whole circumference. [EN 15313, §C.3.2.2 ]

Overheating affecting the wheel rim/web transition [EN 15313, §C.3.2.2 ]

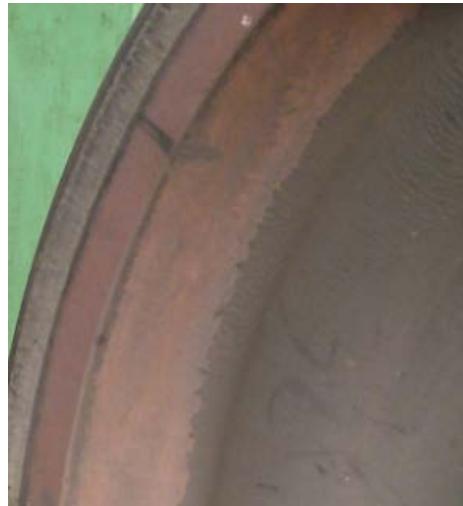
Old and fresh burnt paint

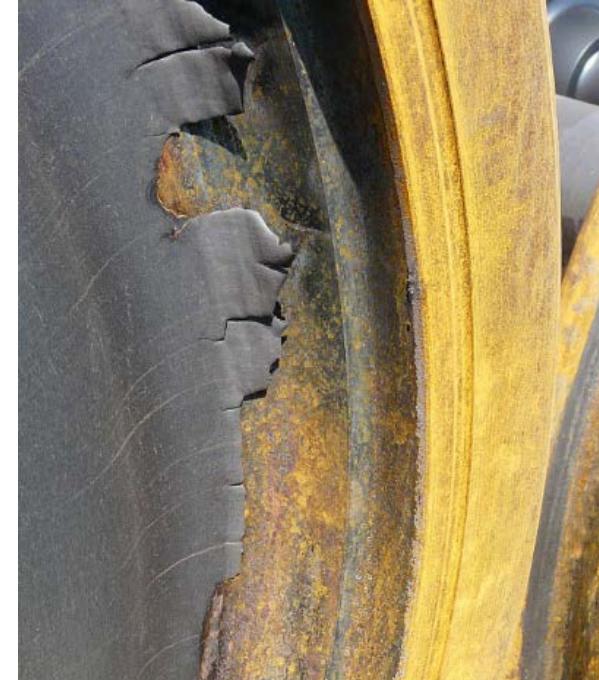
Flanging brake blocks may be an indication of thermal overload.

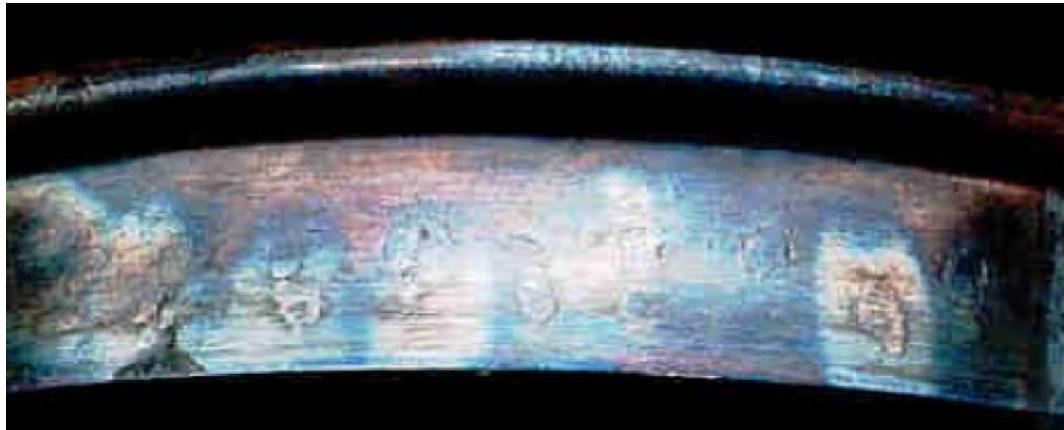
colouring on the tread

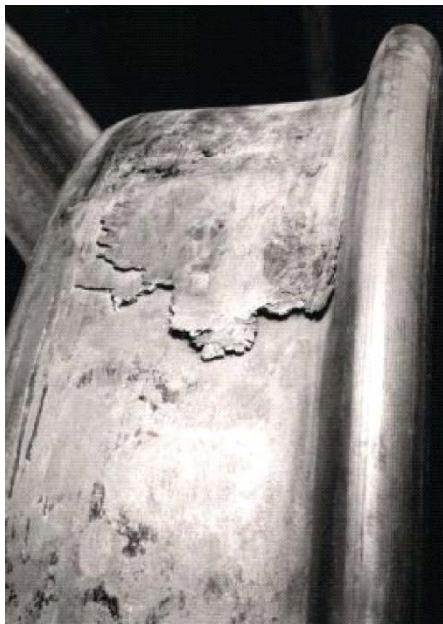
Metal build up on  
the tread

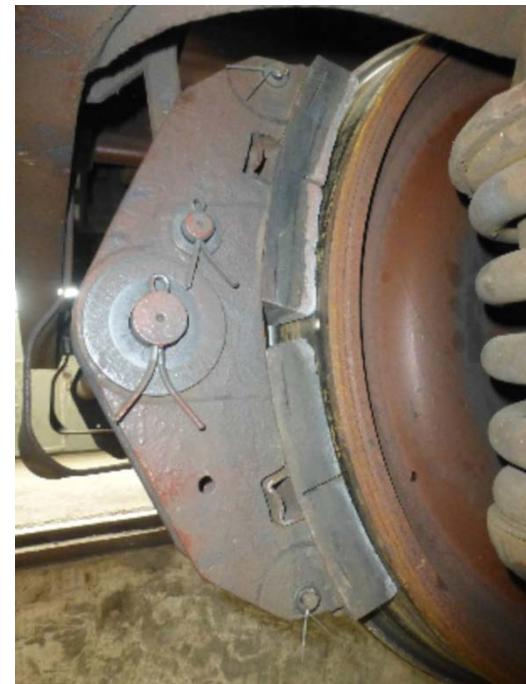
Melted brake block
