Oggetto: Safety Alert. Anormalità di funzionamento del sistema ETCS.

Preliminary report

Incident on the Breda line

Safety incidents on ETCS Level 2 lines in Switzerland on April 16th and June 27th 2019

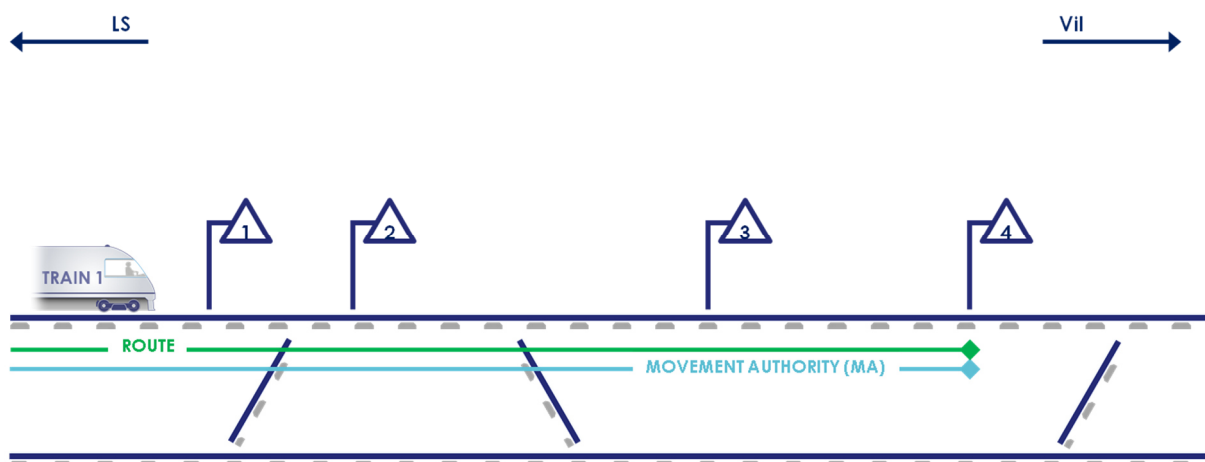
Figure 1

- Train 1 runs from LS to VIL. (set route is indicated in green, MA is indicated in blue).
- All signals have release speed (Figure 1)
- Train 1 shows a large confidence interval (indicated in red) (Figure 2)
- Section between Signal 2 and 3 is occupied by train 1, min SFE remains in front of Signal 2 (Figure 2/3)

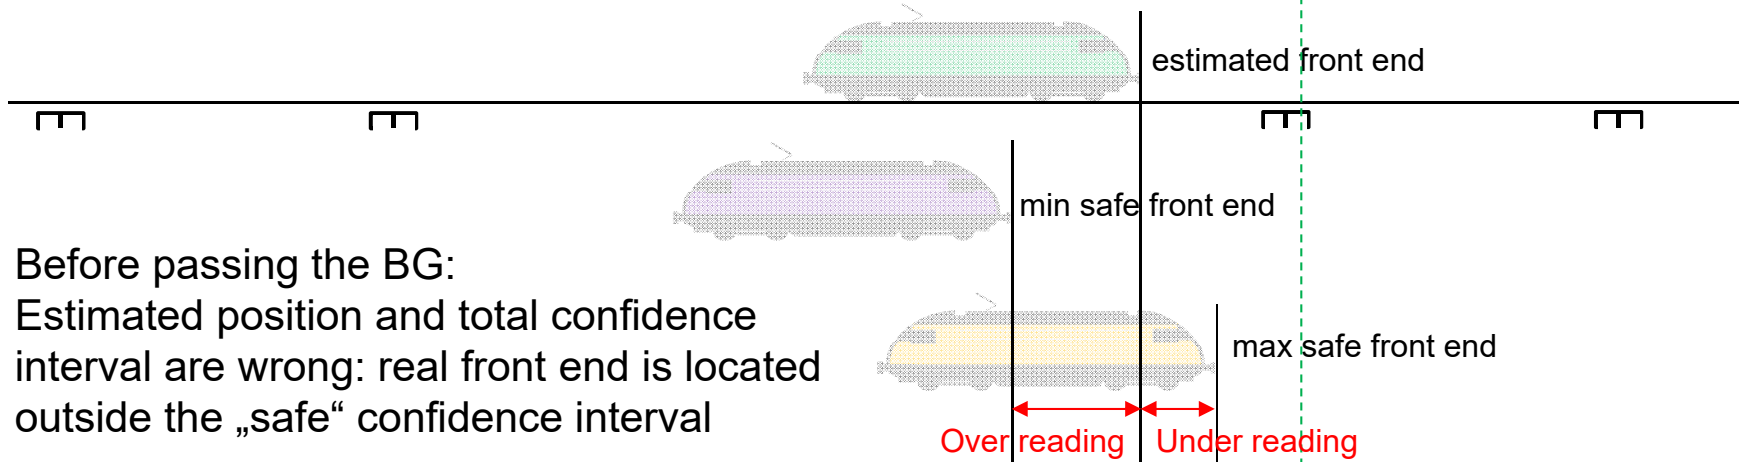
Odometry fault: Real front end outside conf. interval

Before passing the BG:
Estimated position and total confidence interval are wrong: real front end is located outside the „safe“ confidence interval

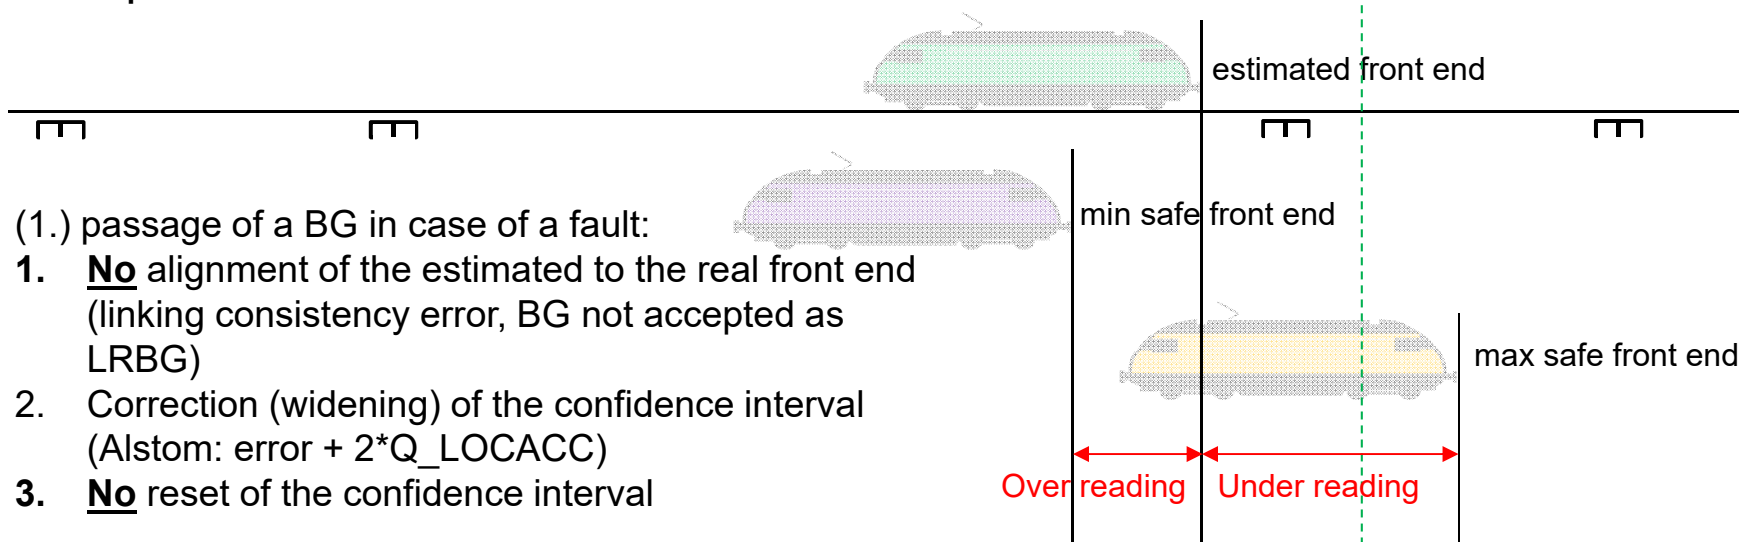
Odometry fault: Passage of balise group

(1.) passage of a BG in case of a fault:

1. **No** alignment of the estimated to the real front end (linking consistency error, BG not accepted as LRBG)
2. Correction (widening) of the confidence interval (Alstom: $\text{error} + 2 \cdot Q_LOCACC$)
3. **No** reset of the confidence interval

Supervision and timely issue of EB not possible when driver surpasses EoA in RS
Danger point behind the signal is reached with high probability unless overlap is large

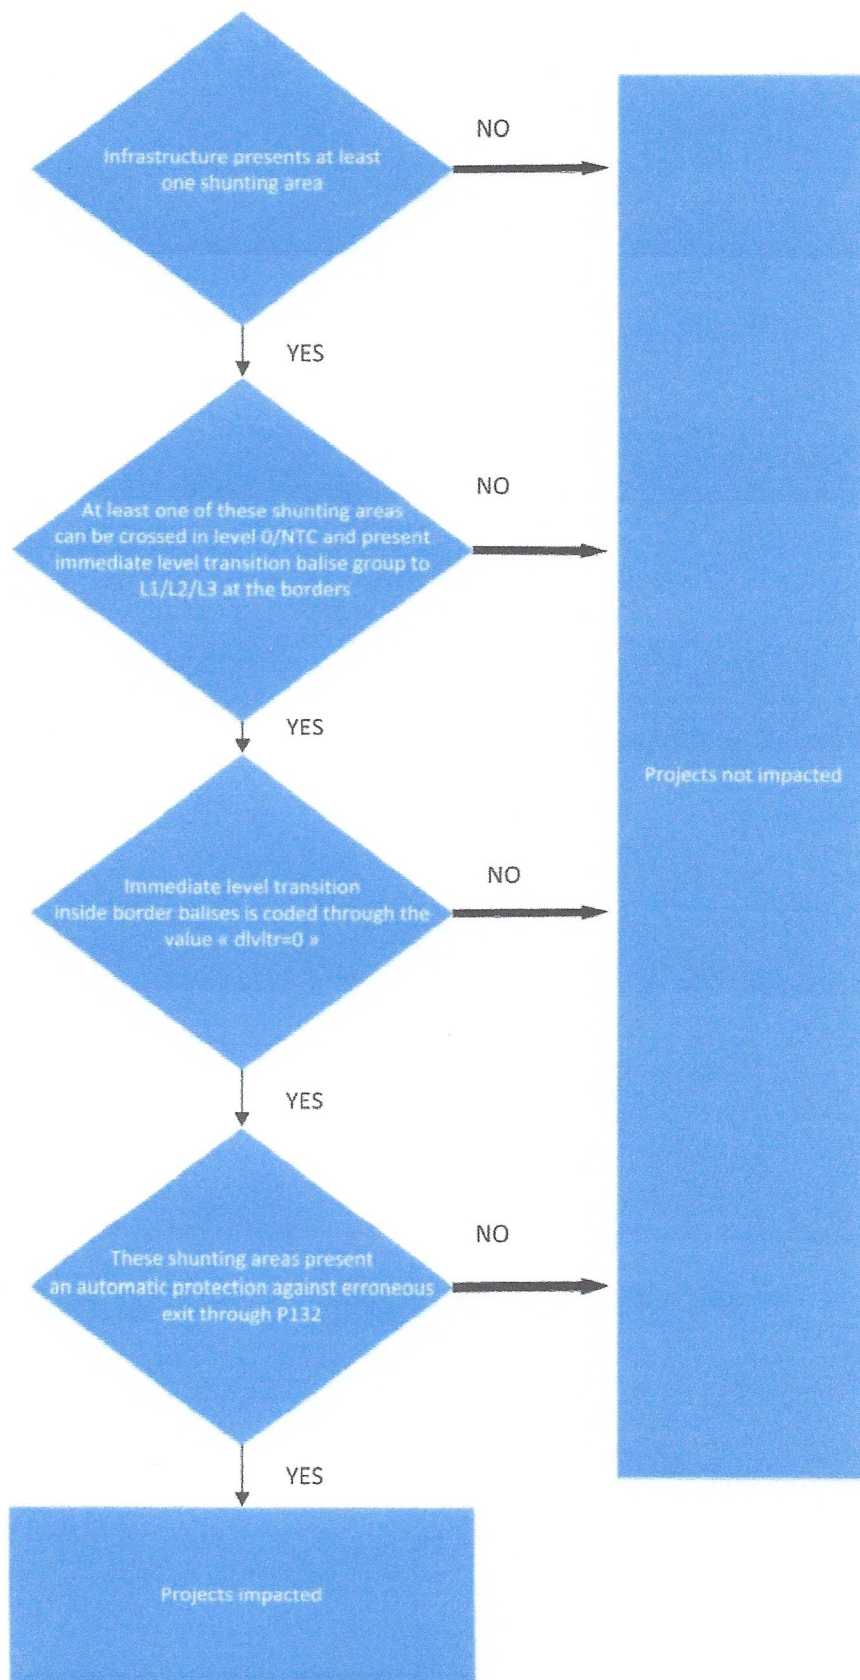
The attached flowchart enables to assess if the potential risk to leave a shunting area while still in shunting mode exists or not.

Should the potential risk be present, our suggestion to avoid any hazard is to adapt the procedure for requesting immediate level transition by using the special reserved value "NOW" for the D_LEVELTR parameter.
