**Oggetto: Safety Alert relativo alla rottura del carrello type Y25Cs prodotto dalla ditta ARAD Romania.**

**Allegato:** Safety Alert inviato dall'Autorità nazionale preposta alla sicurezza delle ferrovie della Polonia (Urząd Transportu Kolejowego (UTK)).

<b>SAFETY ALERT</b>	
Subject	Rolling stock bogies type Y25Cs produced by ARAD Romania
Equipment	Crack of the bogie frame type Y25Cs which was installed on a coal wagon type 412We, manufactured in 2008 by Przedsiębiorstwo Usług Taboru Kolejowego PTK TABKOL S.A. in Rybnik. Bogies of old origin were installed in the wagon, which were built in 1970's and 1980's.
Description	<p>On 6/02/2020 at 0:54 during the passage of a train TME 544018 of CTL Logistics sp. z o.o. from Gdynia Port GPA to Zawiercie GT, the device to detect failure states in rolling stock (DSAT) located on the rail route Górkі - Subkowy in 489.760 km in track no 2 sent a message "GML OSTR" (hot Axleboxes) concerning 7<sup>th</sup> axle when counting from front end of the train and 152<sup>th</sup> axle when counting from rear end of the train. The warning related to 4-axle freight wagon (coal wagon) series Eaos, EVN number 33 56 534 8029-3 loaded with fine coal. The

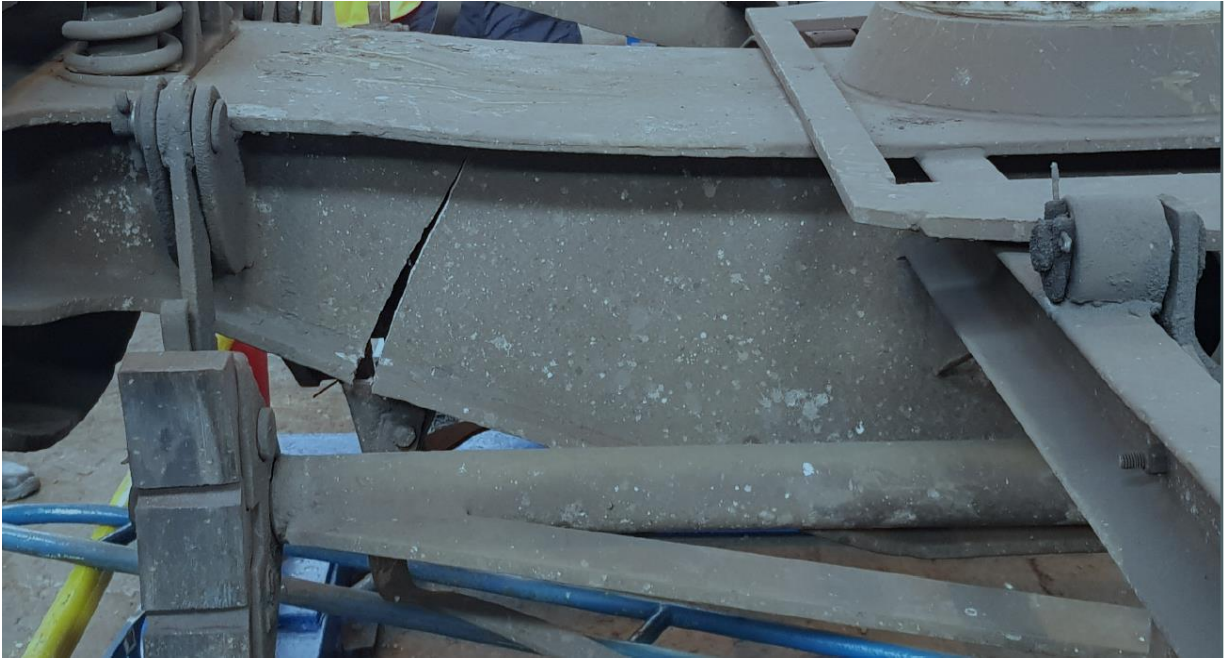
L'avarìa rilevata consiste nella rottura del telaio del carrello tipo Y25C installato su un carro per il trasporto di carbone del tipo 412We, prodotto da Przedsiębiorstwo Usług Taboru Kolejowego PTK TABKOL S.A. Il carrello Y25C è stato prodotto da ARAD Romania, un punto caratteristico riconoscibile del carrello sono i manicotti di centraggio situati su entrambe le estremità del telaio come da foto allegata.

Picture 1. View of the crack at the lower belt of bogie's torsion beam.

Recommendation	It is recommended to carry out additional inspections for cracks in the welded joints of the lower torsion beam of the Y25Cs bogies. In case of any irregularities, the responsible entity in charge of maintenance (ECM) should be notified immediately and the bogie should be repaired.
Country	Poland
Issuer	NSA
Issuing Date	17.06.2020

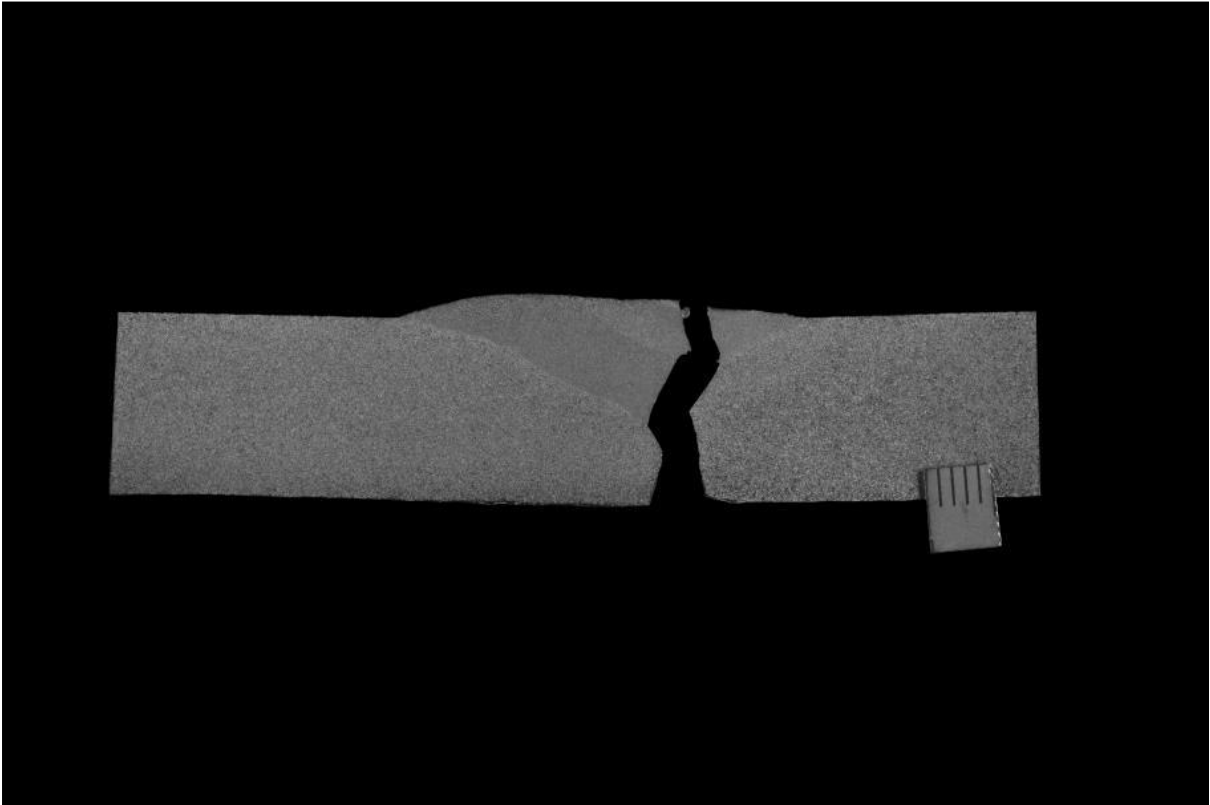
Picture 2. The result of metallographic macroscopic test of a sample taken from broken bogie frame.

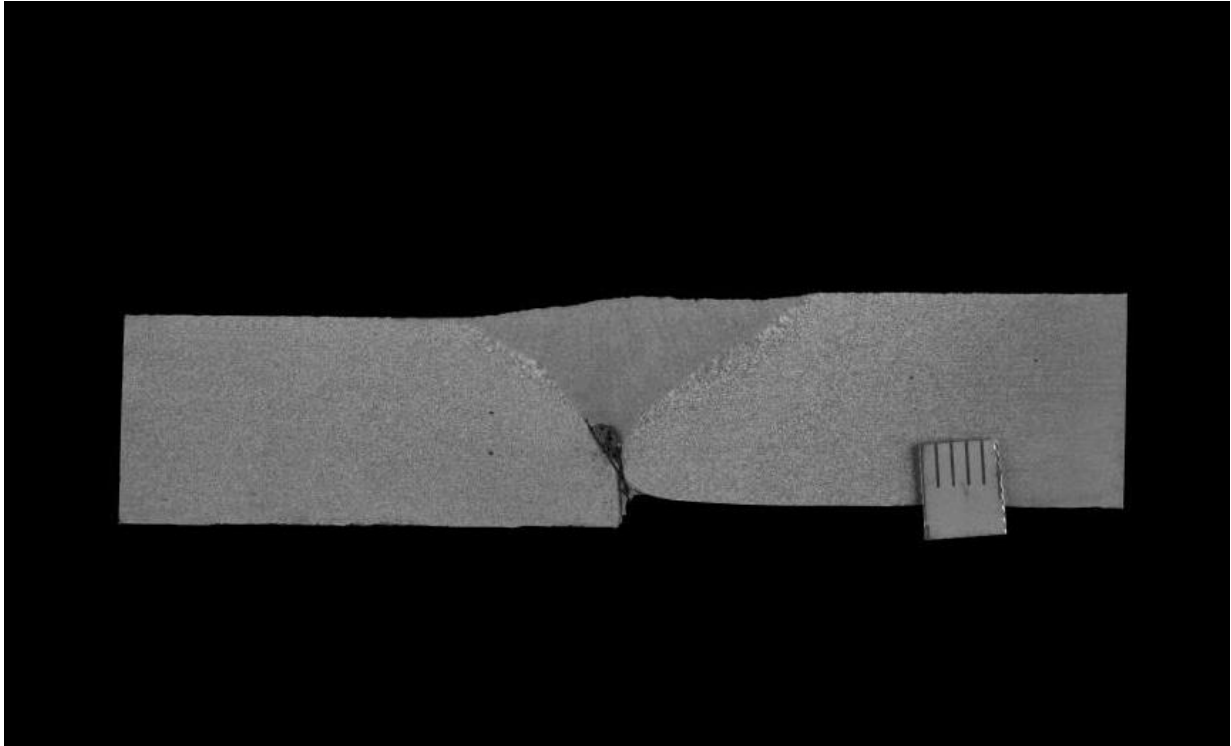
Picture 3. Result of macroscopic metallographic test of the sample taken from an undamaged section of the bogie frame.

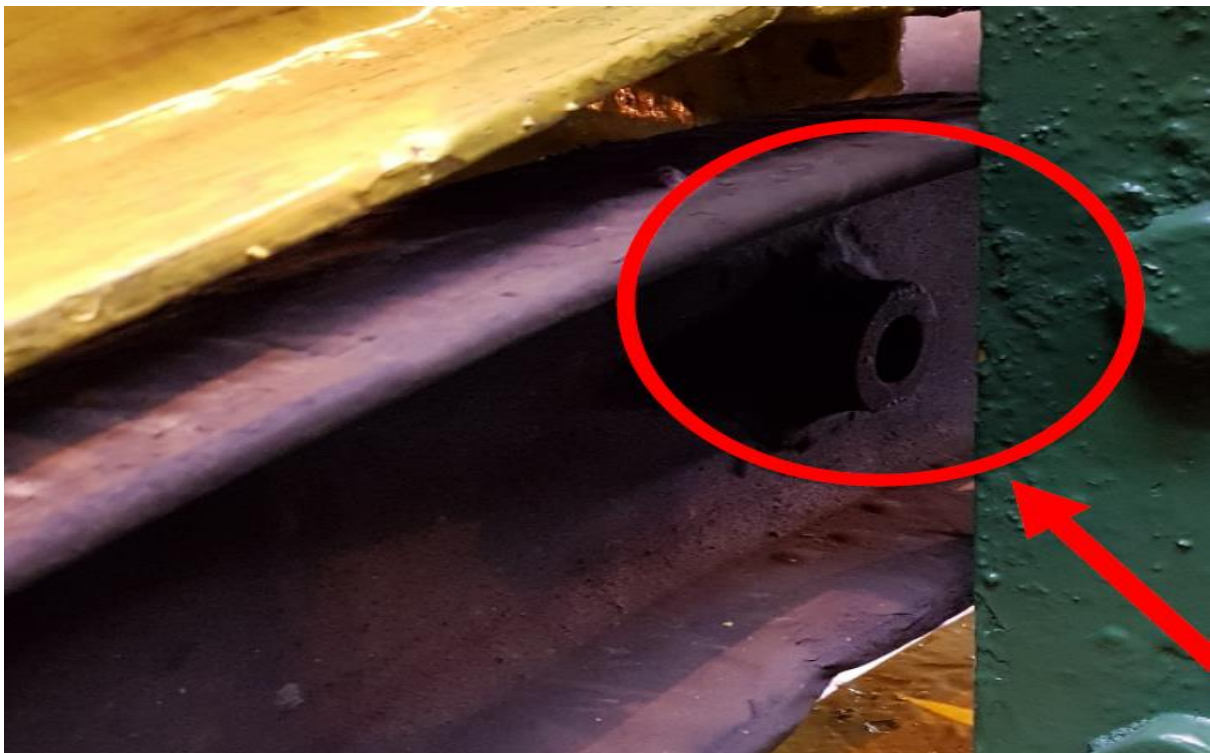
Picture 4. A characteristic point of bogie frame of ARAD Romania production – centering sleeve located on the frame end.
