Oggetto: Inconveniente carro in Germania – Perdita del Serbatoio dell'aria dell'impianto di frenatura.

Allegato: Safety Alert EBA about "Freight wagon, auxiliary air reservoir" con relative foto.

SAFETY ALERT

SYSTEM/ EQUIPMENT	Freight wagon, auxiliary air reservoir		
SAFETY ISSUE DESCRIPTION	Freight wagon Falns 37 80 6654 998-1 D-GATXD, built in Bulgaria in 1989 lost an auxiliary air reservoir (content: 125 l) while passing a station. No derailment and no injuries happened but the following six wagons and the platform equipment were damaged. The loss was caused to a poor weld on the stabilization of the reservoir.		
CIRCUMSTANCES <i>(e.g. special weather conditions)</i>	The reservoir was replaced on the occasion of planned maintenance actions only one month before the accident happened. In the course of this the poor constitution of the welds has not been identified. These wagons were built in eastern Europe at the end of the eighties. Presumably these welds are as old as the wagons. Due to the investigation of the NSA the keeper had checked his fleet and identified two more wagons with the same problem. These wagons had been taken out of operation.

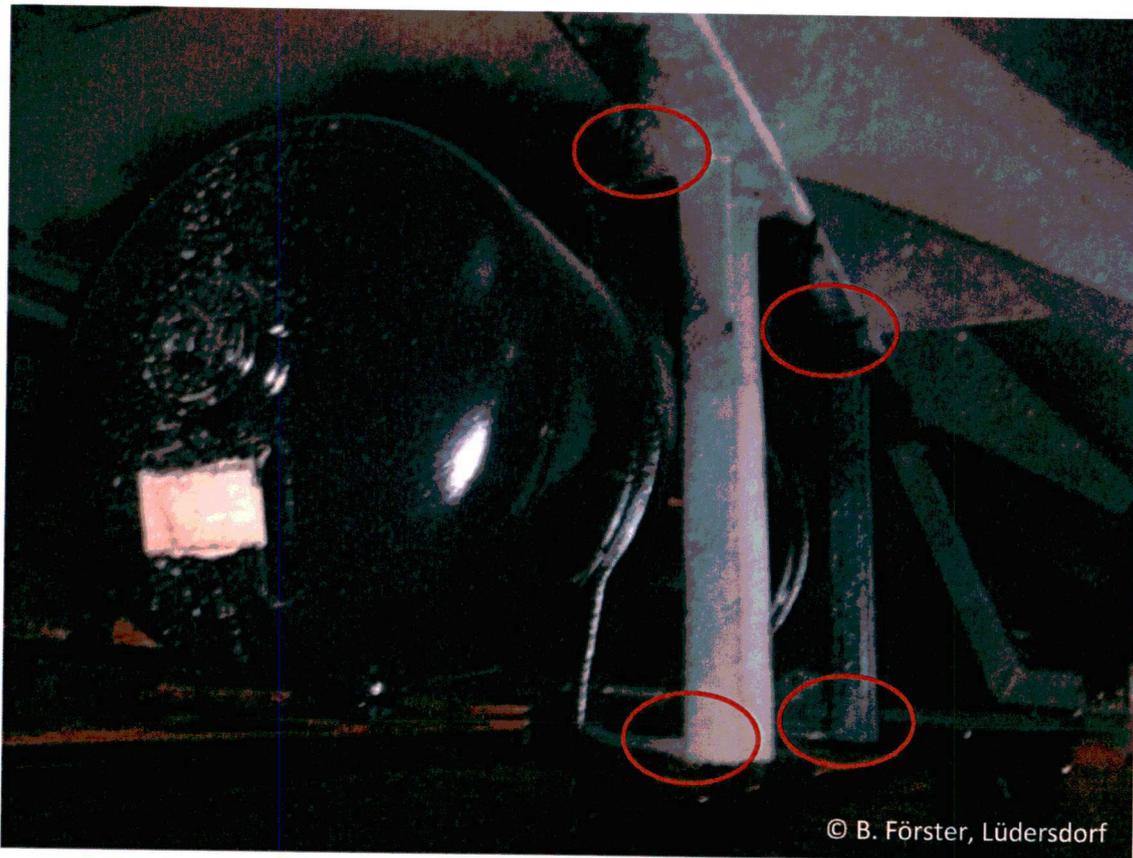
Loss of an auxiliary air reservoir:

Pic 1: auxiliary air reservoir under an affected wagon, welds at the red circles

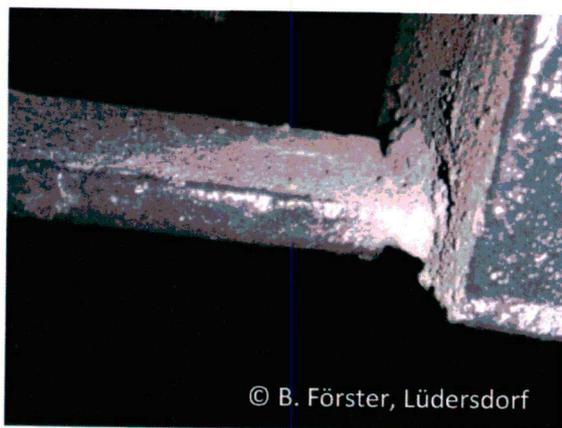
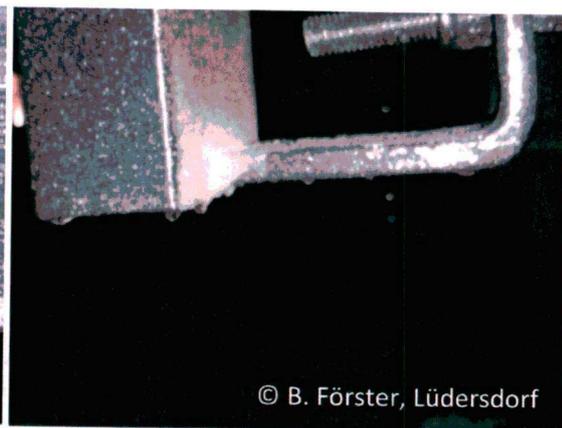
Pics 2, 3: detailed views on affected weld

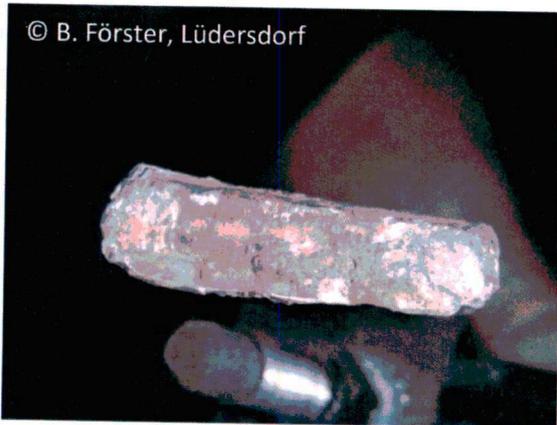
Pics 4, 5: demolished carrying handle and view on the initial position
