**Oggetto: Rottura delle ruote dei veicoli merci. Misure mitigative a breve termine proposte dal
JNS. Aggiornamento del Safety Alert relativo al rilevamento in esercizio della rottura di
una ruota del veicolo NEV 336849544992.**

Joint Network Secretariat
Urgent Procedure Task Force
Broken wheels

**Agreement of the TF on
short term mitigation measures**

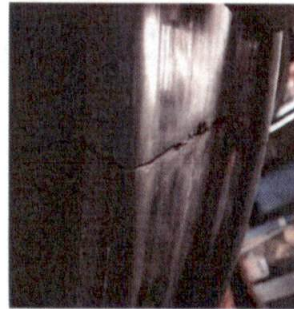
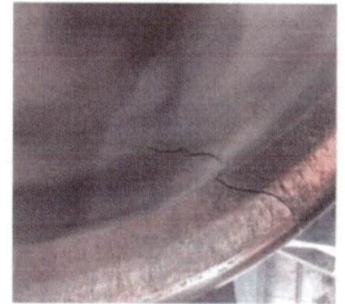
Incidents on wheels BA 314 / ZDB29 (with a slope under the wheel flange) and BA004 in some application show that the actual maintenance plan and operational schemes have to be better kept under control the affected wheelsets.

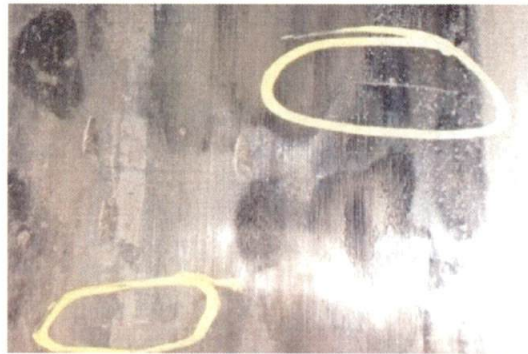
Description: The tread exhibits cracks at an angle of approximately 90° to the circumference of the wheel and have a typical length of 30mm or more. Transverse cracks generally develop at the surface in either straight or slightly crooked lines and can penetrate radially (usually of thermal origin in these cases) or branch out in a circumferential direction (usually of mechanical origin in this case). They occur individually and can be distributed at several points around the circumference. [EN 15313, §C.2.6]

Transverse crack revealed by magnetic particle testing [EN 15313, §C.2.6]

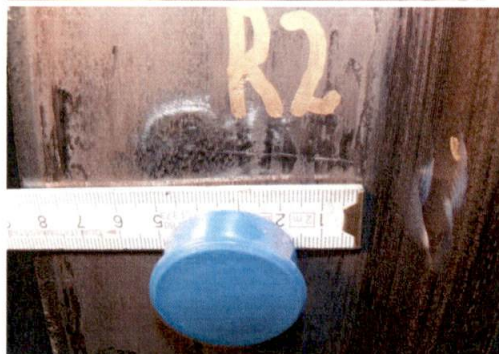
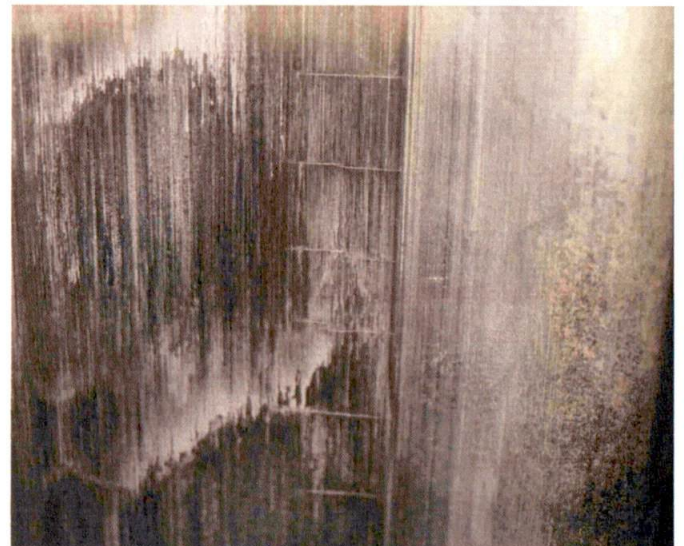
Example for single cracks on the wheel tread by visual inspection

* single cracks on the wheel tread ("isolated transverse cracking" cf. EN 15313 §C.2.6 and 6.2.3.4) – Criteria: see slide 8

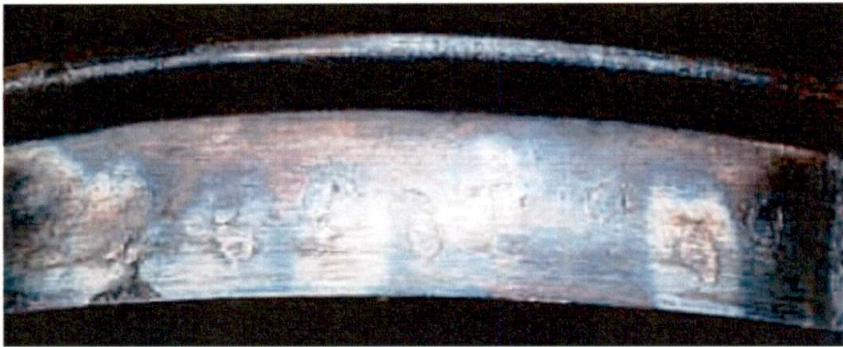
colouring on the tread

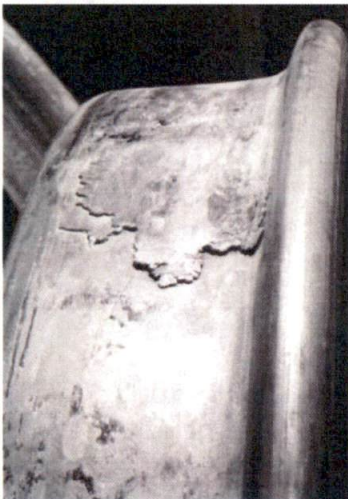
Metal build up on the tread

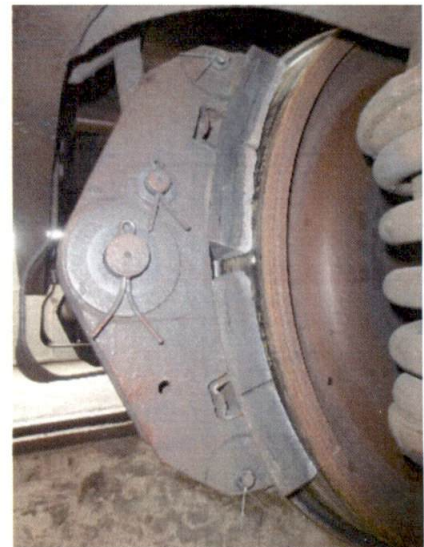
Melted brake block
