## Safety Infor... > Safety Alert > **Freight wagon type Laaiis- Wheelset type BA 390**

Safety Alert

Freight wagon type Laaiis- Wheelset type BA 390

## 1.1 Dinamica dell'evento

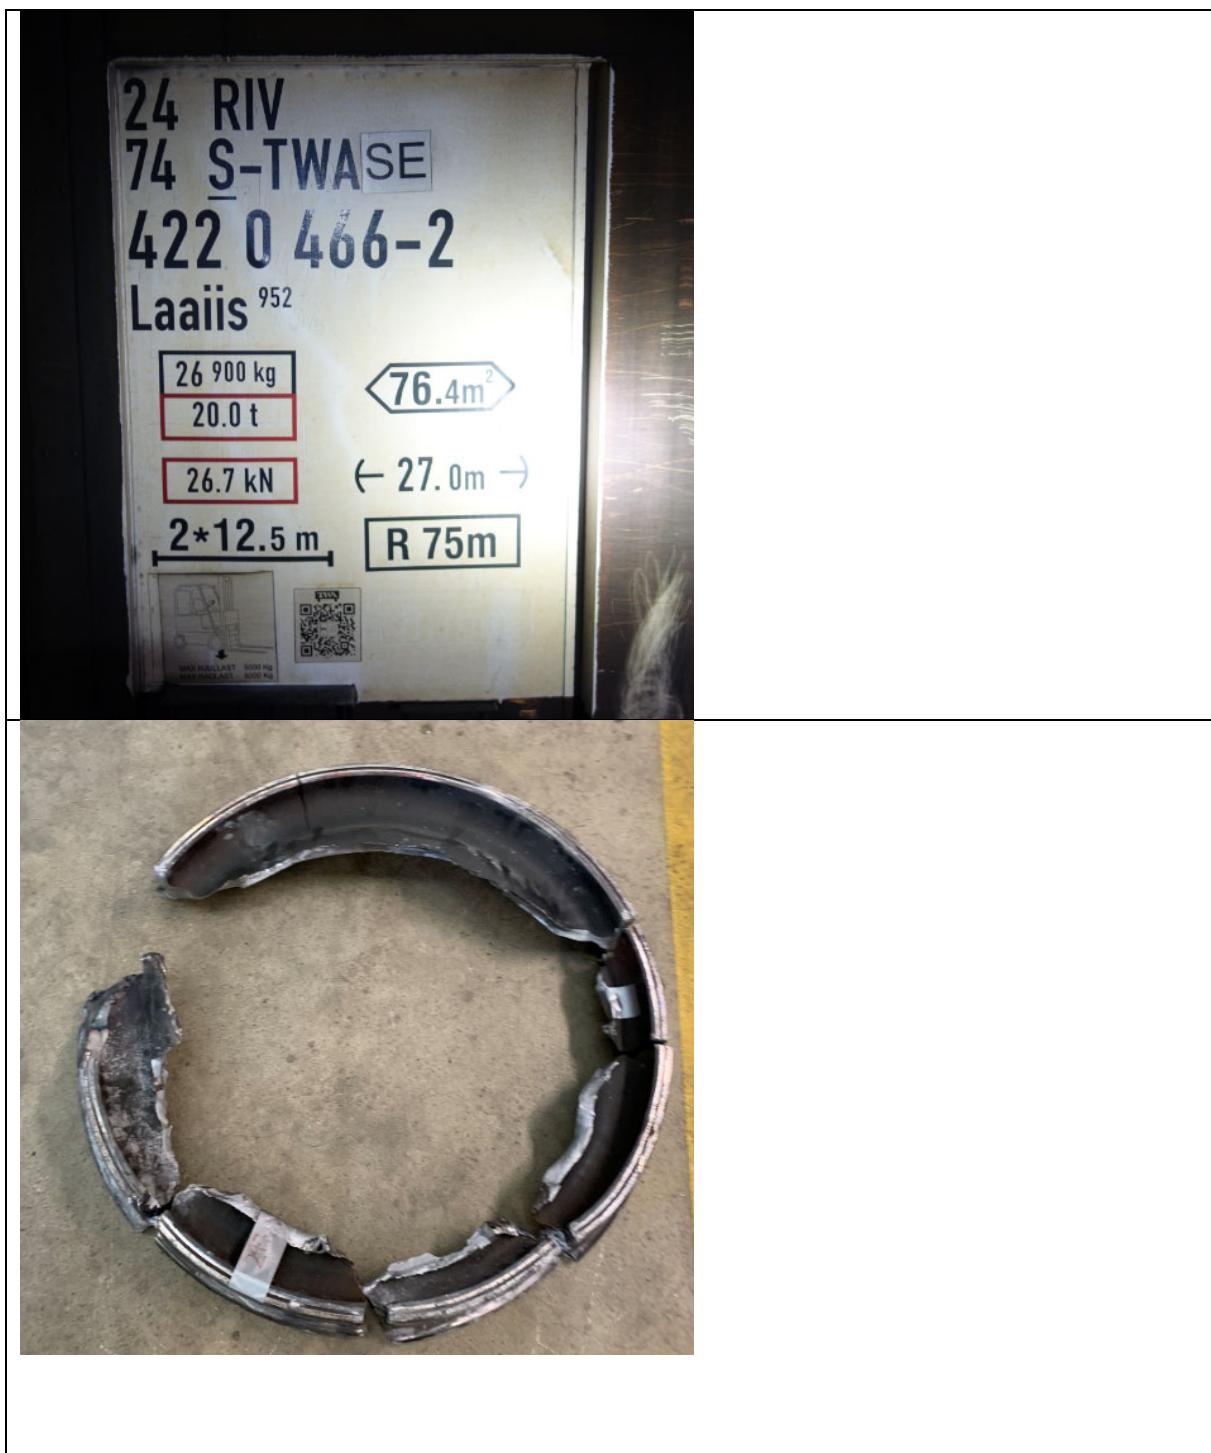
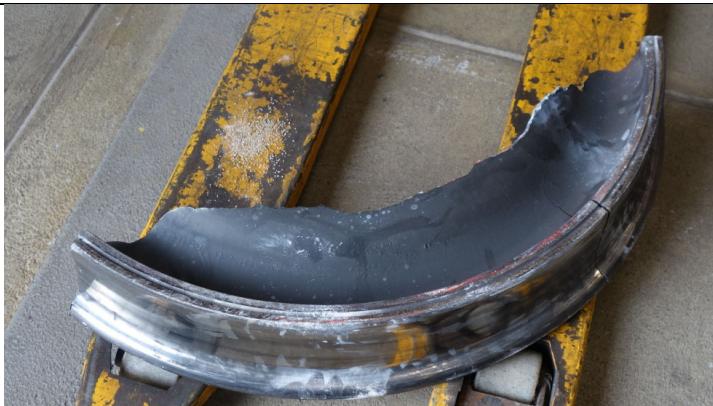
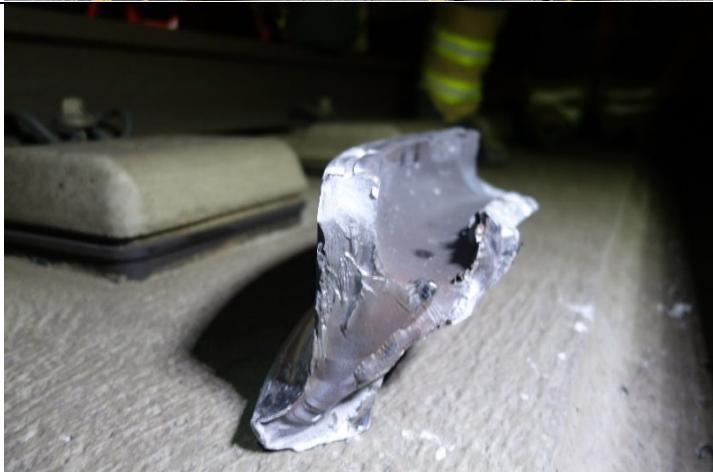
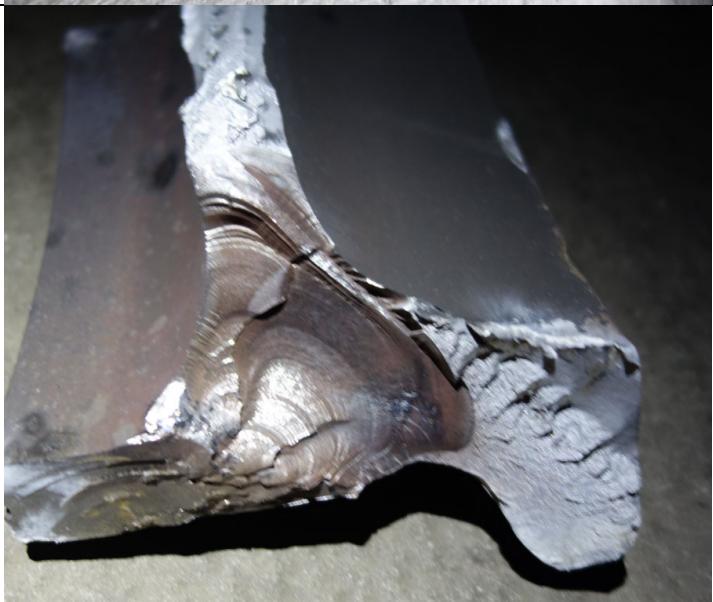
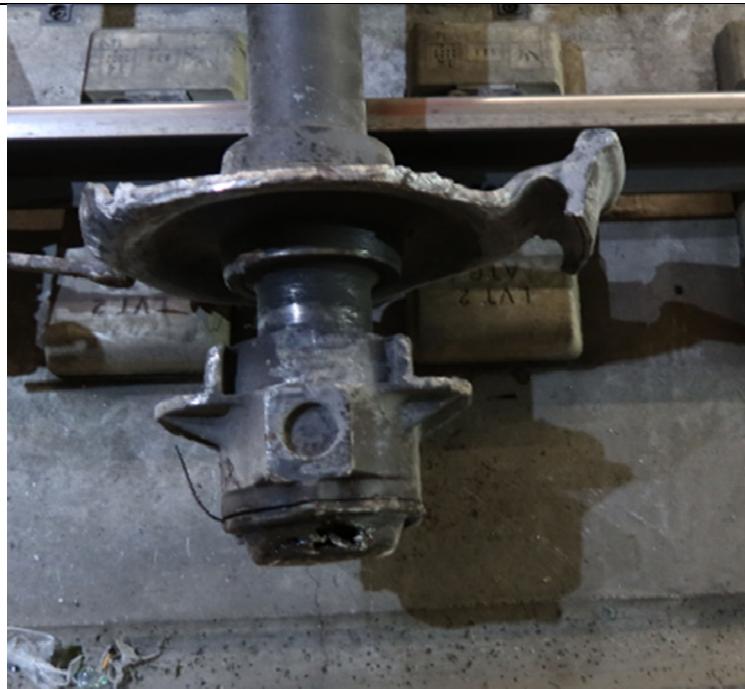
Attachment SIS - NIB-CH Broken Wheel Pictures:

On 10th of August 2023, SBB-Cargo (RU) freight train 45016 was on its way from Chiasso to Basel with two locomotives (BR 185) and 30 different wagons. Approx. 10 km after entering the South portal of the Gotthard Base tunnel, a piece of the wheel of the first wheelset of the 11th wagon broke. Shortly afterwards, other pieces came off the wheel. The wheelset was still hanging crosswise under the wagon. This track section is equipped with bi-block sleepers. The wagon then continued for about 4 km in the tunnel without causing any major damage to the infrastructure. Shortly before the multifunction station Faido at approx. km 17 from the tunnel portal, a last wheel stub broke. The wheelset, which was still attached to the wagon, derailed under the wagon and hit the sleepers in front of the Faido switch. As a result, sixteen wagons derailed and partially overturned in the tunnel.

The wagon is from type Laaiis. The wheelset is from type BA 390 and the brakes are fitted with composite brake blocks, type LL. The wheelset has travelled approximately 140,000 km since his last IS2 (program VPI 04) inspection at the end of 2017.

A metallurgical analysis of the broken wheel is underway. An interim report was published by NIB CH on 28th September 2023 and is publicly available on the website of STSB (NIB CH) in German (only language version available for the moment) at the following link:

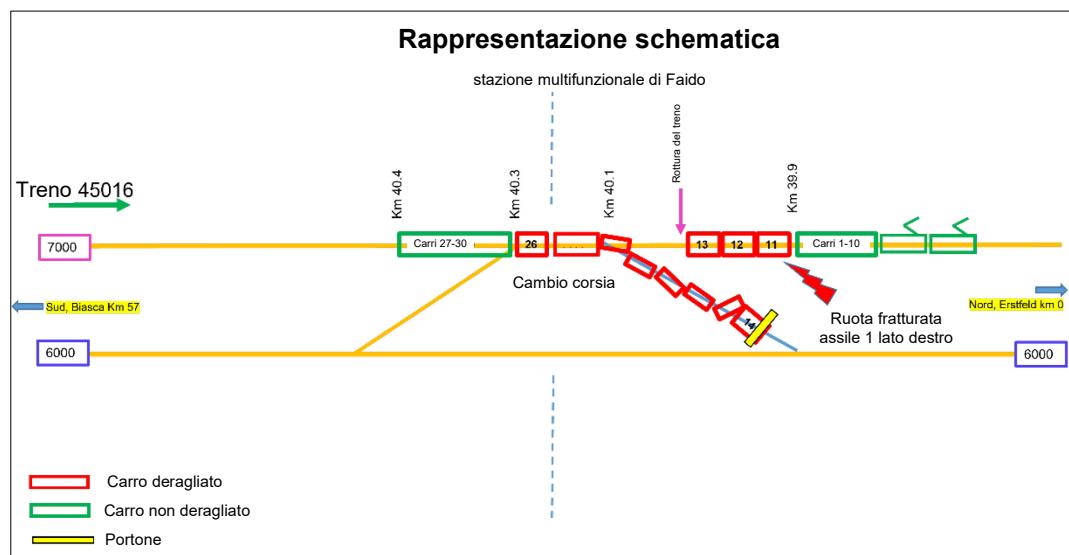
**Figura 1:** Rappresentazione schematica della posizione dei carri dopo il deragliamento e l'arresto del treno merci.

Il 10 agosto 2023 il treno merci 45016, operato da FFS Cargo e composto da due locomotive (BR 185) e 30 carri merci di vario tipo, stava percorrendo la tratta da Chiasso a Basilea. Circa 10 km dopo l'ingresso nel portale sud della galleria di base del San Gottardo – al km ferroviario 47 – un frammento si staccava dalla ruota (Figura 2) del primo assile in direzione di marcia dell'11° carro, seguito a breve distanza da altri frammenti di ruota (figure 3–4). In quella zona l'infrastruttura mostrava lievi danni alle traverse biblocco in cemento armato. Da quel momento in poi l'assile pendeva in diagonale sotto il carro. Il treno merci proseguiva la corsa per altri 4 km circa, senza lasciare tracce rilevanti sull'infrastruttura. Poco prima della stazione multifunzionale di Faido, circa 17 km dopo il portale della galleria, in corrispondenza del km ferroviario 40.4 si staccava un ultimo frammento di ruota. L'assile, sospeso in posizione obliqua sotto il carro, urtava le traverse monoblocco in cemento armato davanti al deviatoio di cambio corsia di Faido, distruggendo tutti i meccanismi di azionamento dello scambio. Il danneggiamento dello scambio provocava il deragliamento e parziale ribaltamento in galleria dei successivi sedici carri merci. Il convoglio si spezzava in due tra il 13° e il 14° carro e alcuni vagoni finivano sul binario deviato (Figura 1).

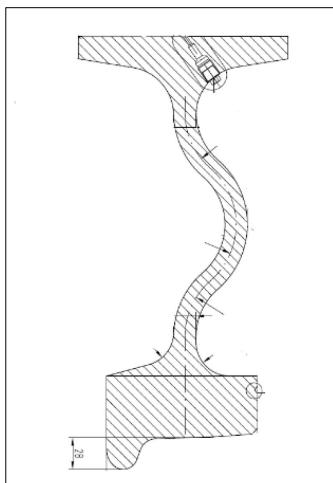
**Figura 6:** Disegno del tipo di ruota BA 390 (fonte: disegno del tipo).

La ruota fratturata è una ruota monoblocco di tipo BA 390 (Figura 6) con un carico per asse di 22.5 t. La qualità dell'acciaio è ER7. La ruota è stata fabbricata nel 2008.

Dalla sua ultima manutenzione (IS2<sup>3</sup>), l'assile ha percorso circa 140 000 km. Il diametro della ruota era di 862 mm. Le suole dei freni sono di tipo LL (suole in materiale composito).

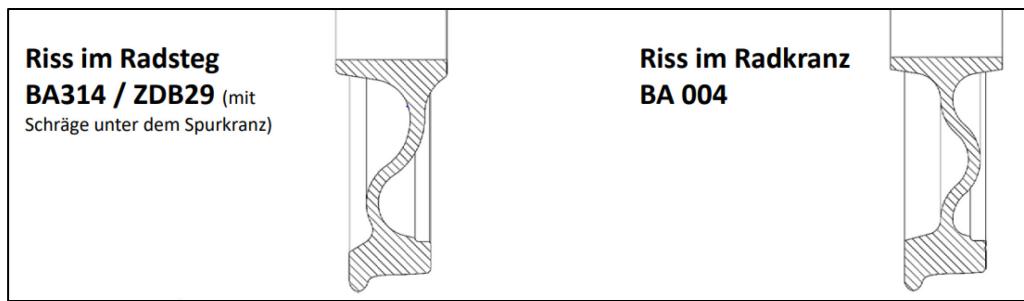
**Figura 12:** Tipi di ruote soggetti a rotture e cricche (estratto del documento JNS).

Negli anni 2016 e 2017 si sono verificate in Italia e in Belgio svariate rotture e cricche ai danni di carri merci con ruote di tipo BA 314 e BA 004 (Figura 12).

Per quanto riguarda le cricche nella corona della ruota di tipo BA 004, il documento afferma che in alcune applicazioni la probabilità che si innescino difetti di origine termica è maggiore.

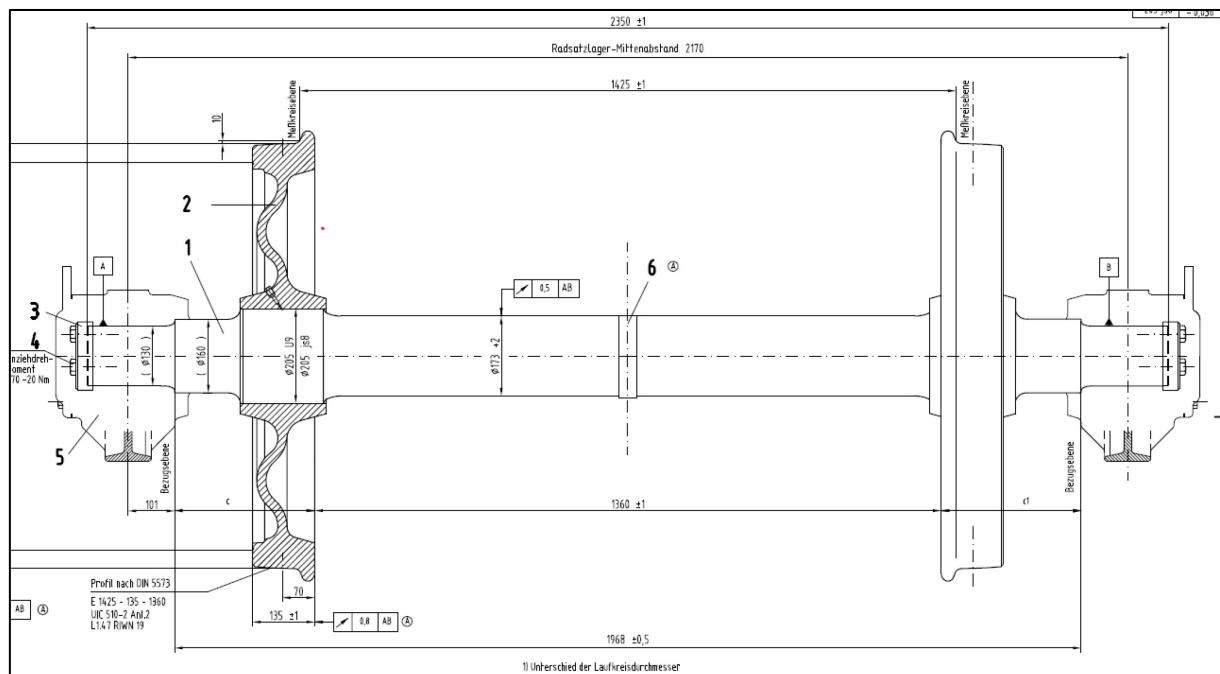
**Figura 14:** Sala montata BA 390.

Si tratta di una sala montata di tipo BA 390 (allegato 2, Figura 14).

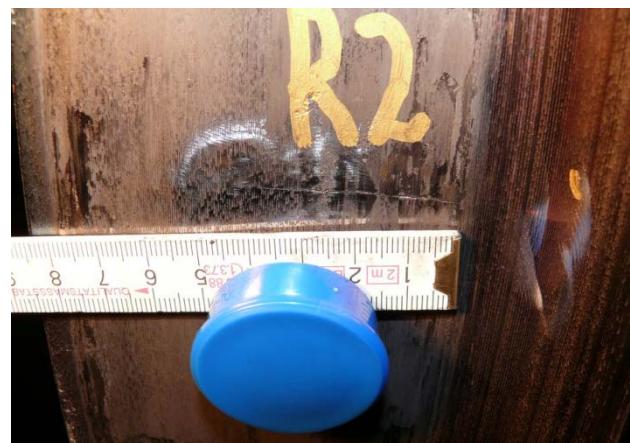
Transverse crack revealed by magnetic particle testing [EN 15313, §C.2.6 ]
