Oggetto: Safety Alert. Anormalità di funzionamento del sistema ETCS.

Preliminary report

Incident on the Breda line

Safety incidents on ETCS Level 2 lines in Switzerland on April 16th and June 27th 2019

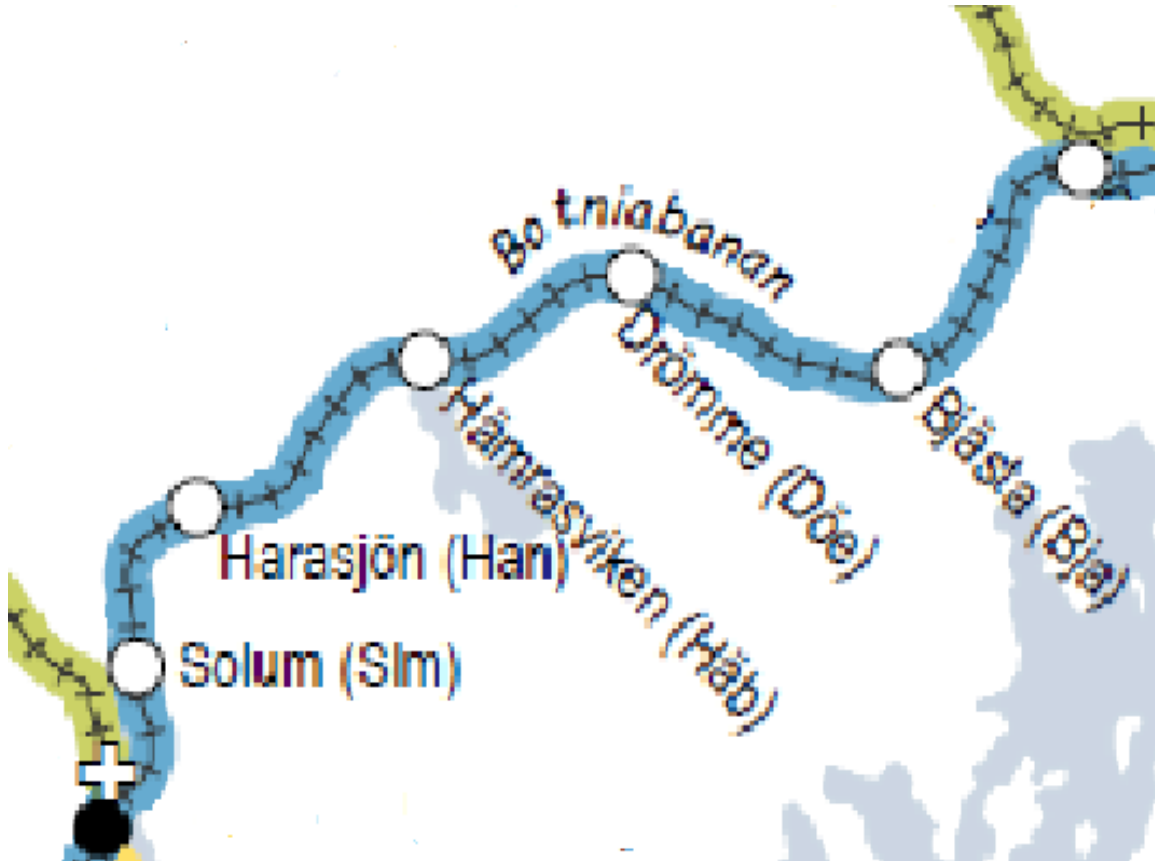
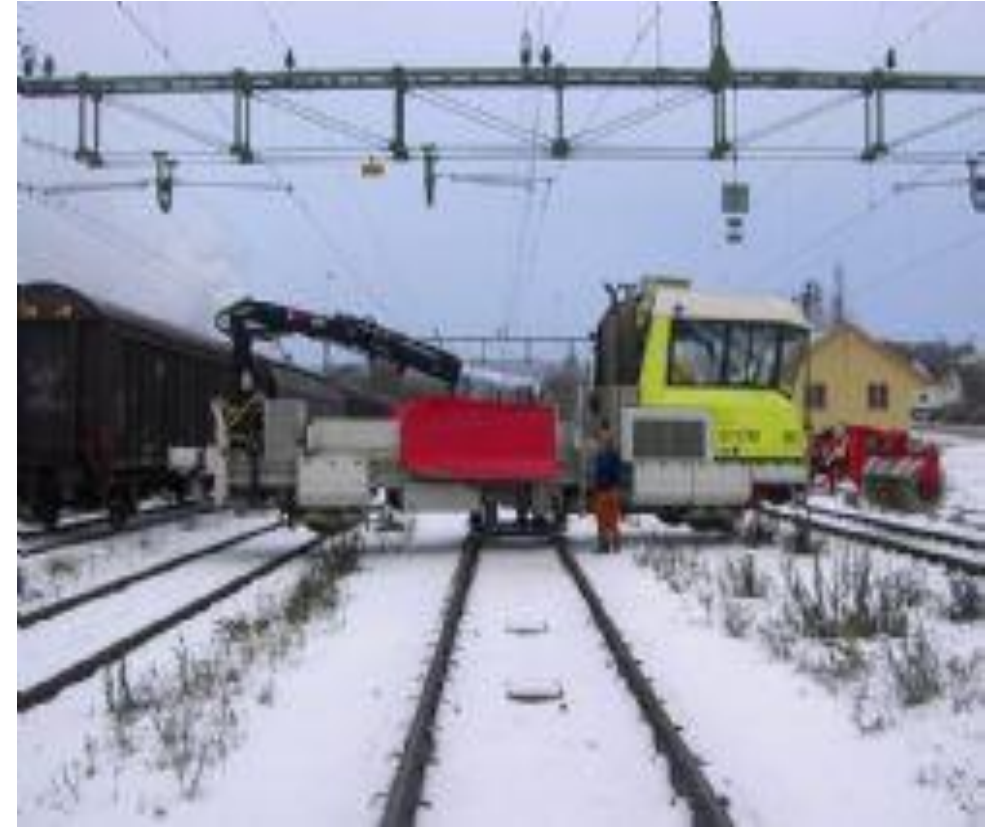
The line. The maintenance vehicle.

13 September 2019

1. The maintenance vehicle started with a movement authority, operating mode "full supervision" (MA-FS) from Harasjön track 1 (intermediate board 33, balise group 140).
2. The vehicle stopped out on the line after having passed balise group 131, but before balise group 120.
3. The driver performed a "End of mission" and the MA was withdrawn.

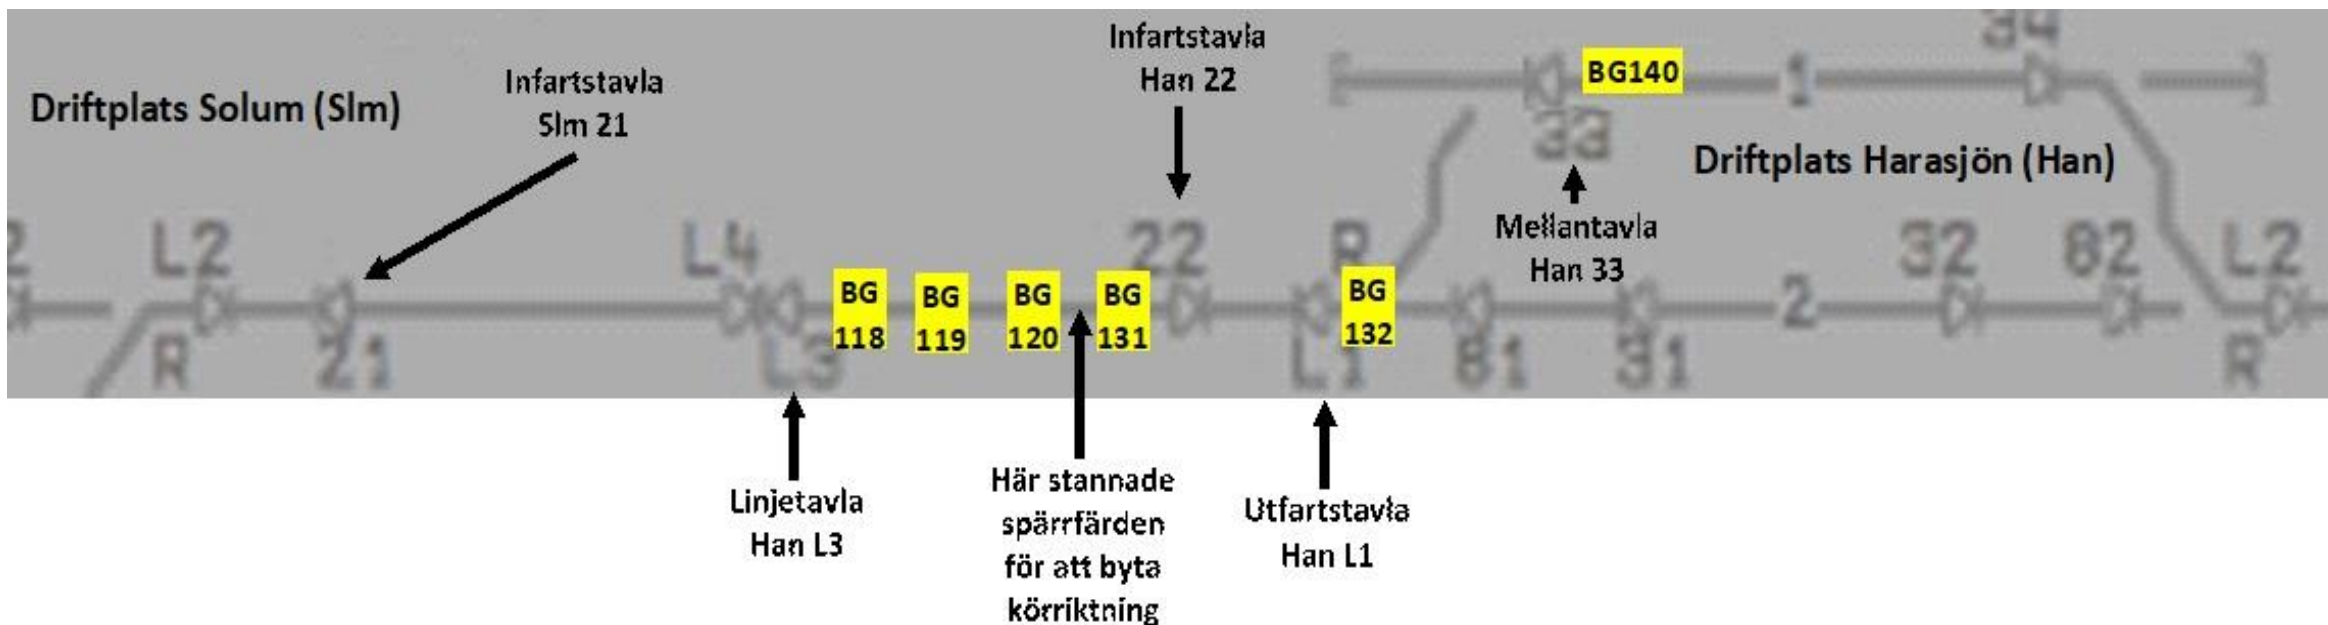
4. The driver try twice to activate the B-cab of the maintenance vehicle. The request for a MA is made through the ETCS on board system. The attempt fails.

5. Then the B-cab is de-activated, and the A-cab re-activated again.
6. Now the driver makes a turn of the complete vehicle by using the in-built turning plate. However, the ETCS onboard system is not restarted when using the turning plate.

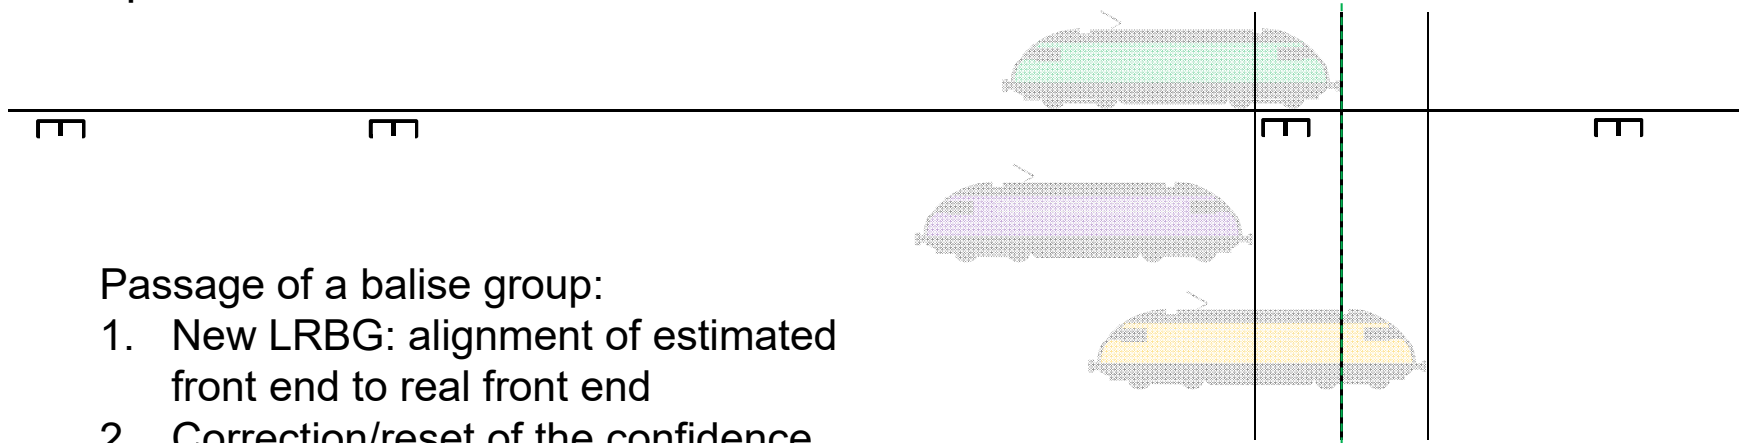
Perspective of vehicle

Passage of a balise group:

1. New LRBG: alignment of estimated front end to real front end
2. Correction/reset of the confidence interval (location accuracy of the BG + small tolerances)
